**SOIL EROSION PROCESSES AND CONTROL ON  
RURAL ROADS IN MT. ELGON SUB-COUNTY,  
TRANS NZOIA AND WEST POKOT COUNTIES,  
KENYA**

**A THESIS SUBMITTED IN PARTIAL FULFILMENT OF MASTER  
OF SCIENCE IN ENVIRONMENTAL STUDIES  
(ENVIRONMENTAL EARTH SCIENCES)**

**2015**

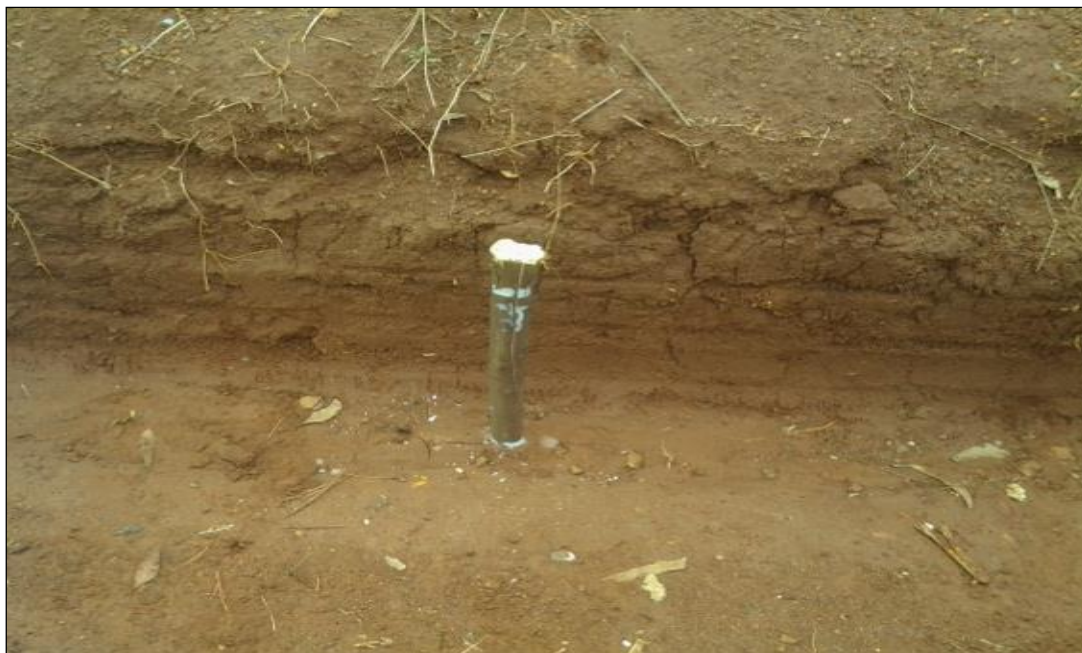
**Figure 3.1: Erosion peg at 0+500m on Kuywa-Kopsiro Road. Author (Source 2013).**

The pins were of standard average length of 70 cm which were driven into the soil to give a firm stable datum: 20 cm was typical, less for a shallow soil, more for a loose soil approximately 30-45 cm driven into the ground. The pins had an average diameter of 50 mm; thick pins could interfere with the surface flow and could cause scour. A total of 86 pegs were driven into the ground (Table 3.2 for peg distribution per road). Rock and tree roots painting was also done in sections of West Pokot on areas with rocky road surface and zones where pegs (Figure 3.1) could probably be plugged out or infested by pests like termites.

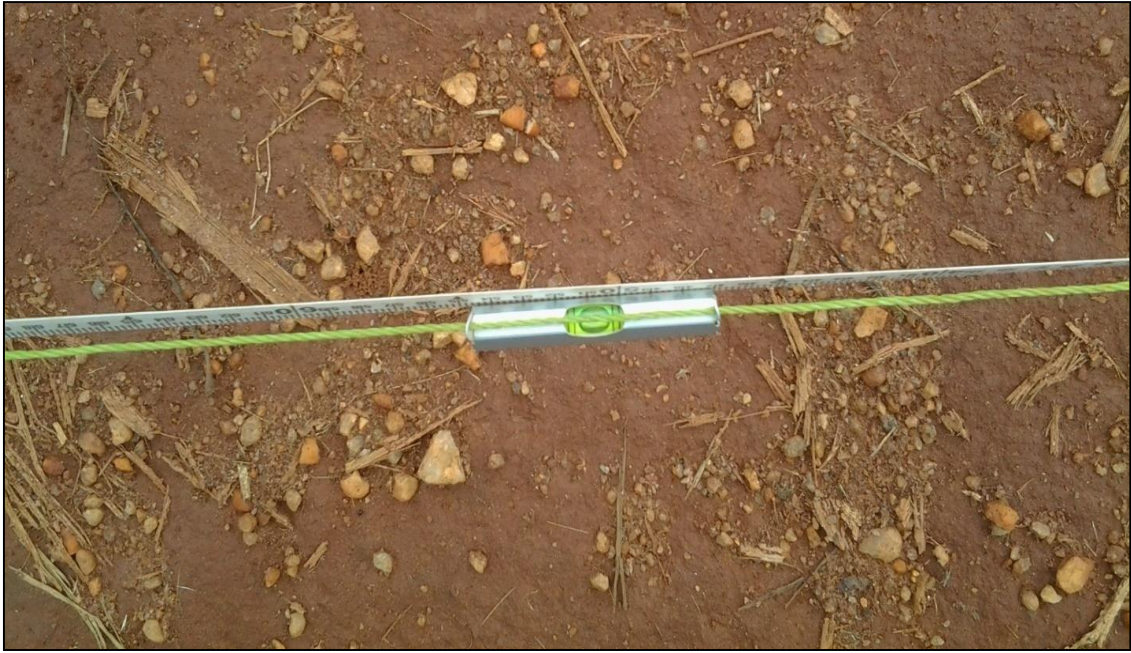
**Figure 3.4: Measurement of slope using line and level. Author (Source 2013).**

The average percentage of slope was determined by using a silvaclinometer/clinometer. This was done by averaging the slopes of short road sections of nearly uniform gradients. For each road segment the observer stood at one end of the segment and targeted research assistant. The results for all the segments were recorded together with the length of each segment. The lengths were then used to calculate the modal slope, i.e. the slope recorded by the greatest number of sections of each road segment. Slopes were determined by physical measurements on the ground by using a tape measure and a string fitted spirit level (Figure 3.3).

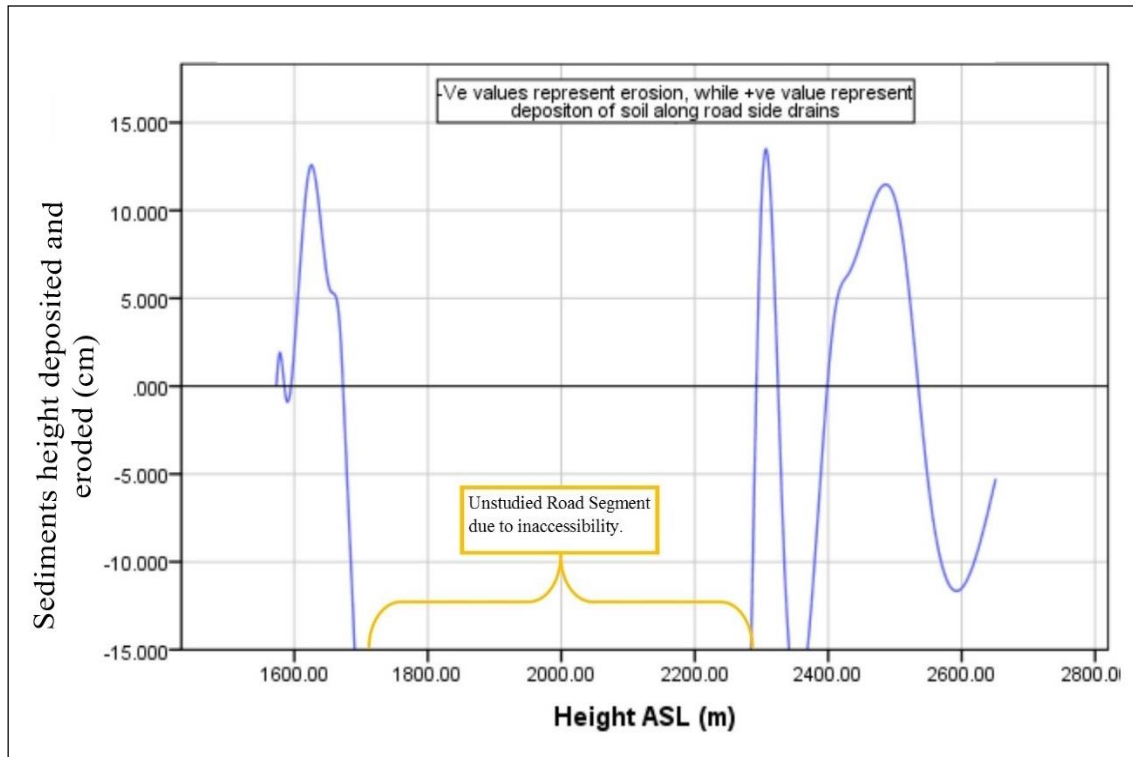
**Figure 4.7: Sediments change deposited/eroded in Kuywa- Kopsiro road.**

and inaccessibility of the road, the inaccessible part is 2 km from Kapkateny River to Chemisto Primary school in C51 road leading to Kapsokwony, this in the figure 25 below is represented by the missing values after 1800 m to 2200 m.

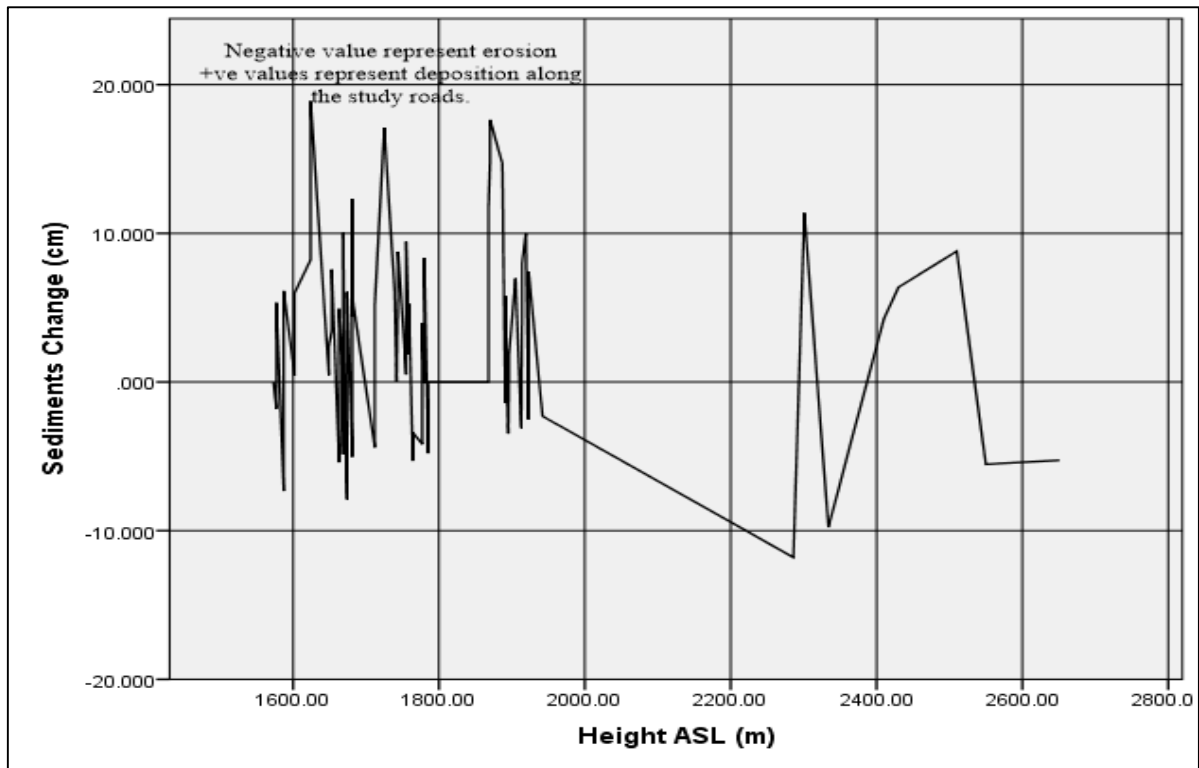
**Figure 4.8: Sediments change versus Volume in Chepareria-Priokwo.**

The data was analysed using a line graph (Figure 4.8). The data collected was discrete from sampled points of the road segments. However, for projection of the representation of the entire road segments there was need to perform a projection for the entire sampled roads, to give a representation of unsampled road locations indicating their soil processes activities.

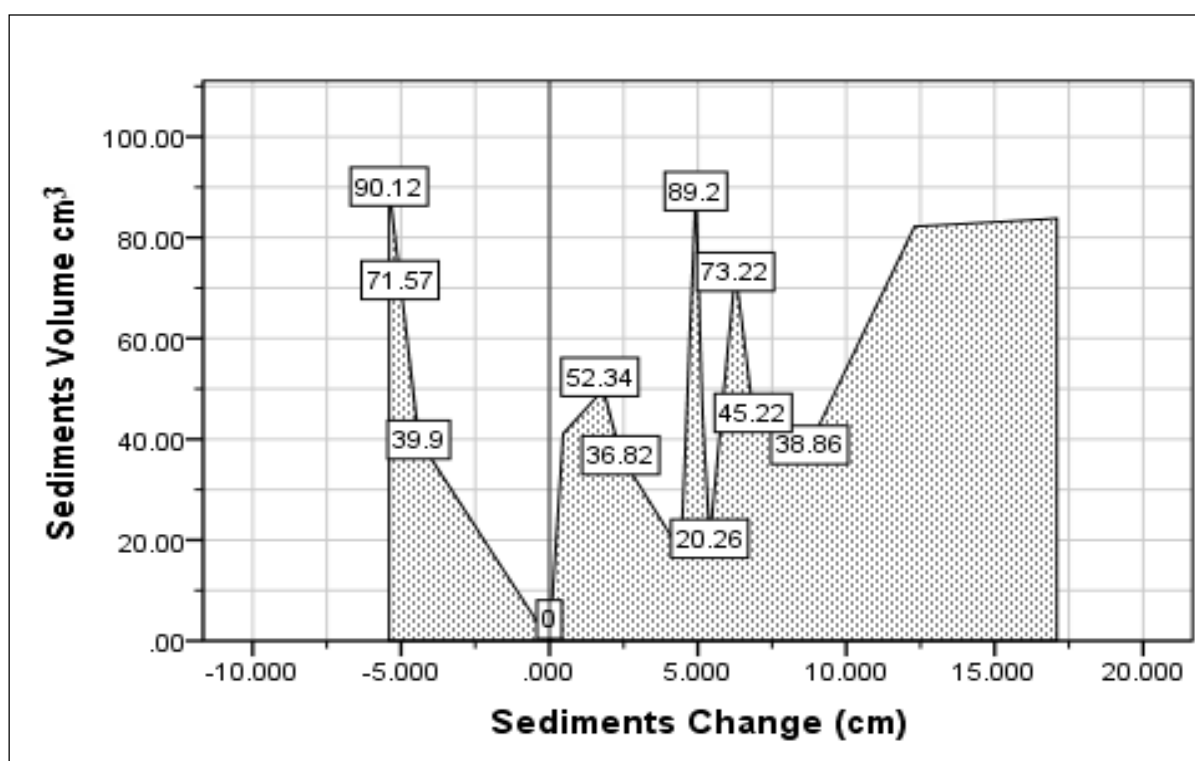
**Figure 4.9: Sediment volumes in West Pokot.**

Erosion in West Pokot was not that intensive but it was a progressive and widespread across the road system, with maximum value of -5.4 cm. The erosive level was persistent in all seasons from dry to rainy seasons with a Standard deviation of (4) in rainy season and (11) in the dry months of January. The erosion in the roads occurred on side drains and in areas with descending profile leading to either a dry river valley or a river.

The average deposited sediments in west Pokot was higher than the eroded sediments from the road (Figure 4.19). The volume of eroded sediments was less at 202 cm<sup>3</sup> compared to deposited sediments which was 356 cm<sup>3</sup>. The general trend of west Pokot roads was deposition, while erosion accounted for less than 40% of soil movement and deposition was higher on lower sides of the road and along dry river beds. The probable source of sediments could be from adjacent farms or transported from distant locations by water action. The sedimentation materials were deposited on the roadside damaging road soil control works and blocking culverts, shattering drifts and bridges in the area.

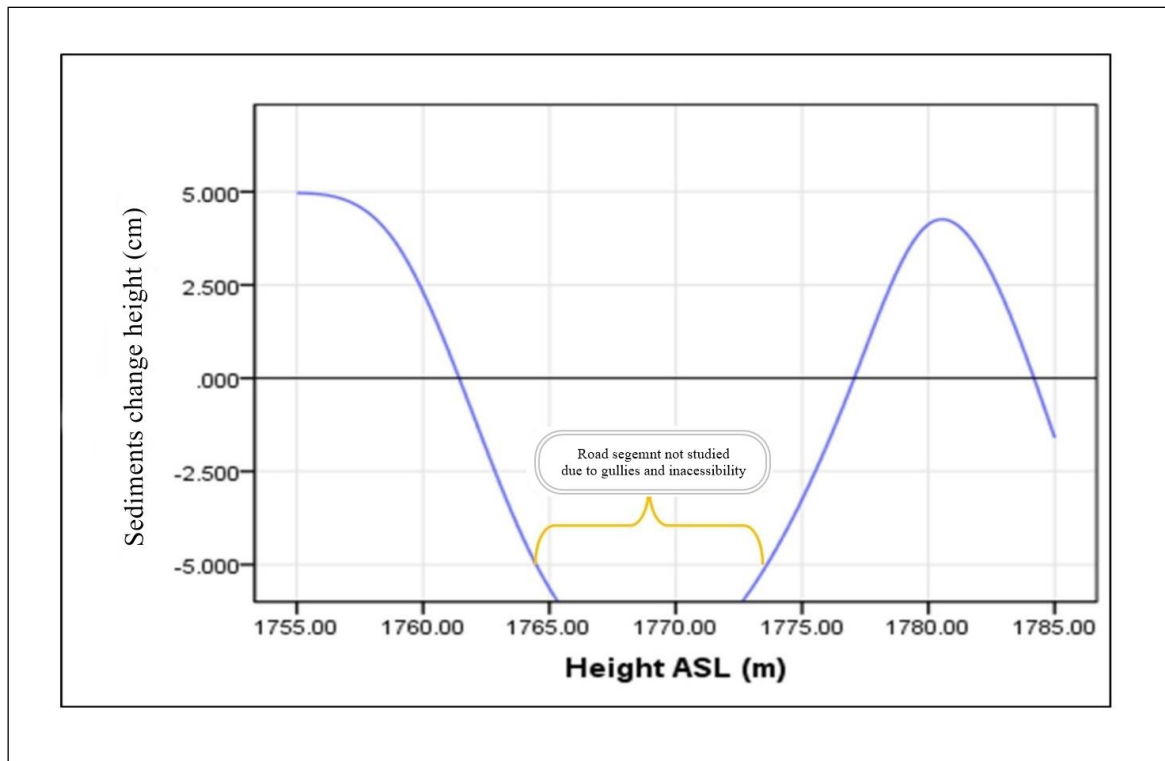
**Figure 4.11: Line graph of eroded/deposited sediments change versus ASL in Sikulu-Kinyoro road.**

Sikulu-Kinyoro lies on a rolling plain and it covers 8+200 km from Saboti Junction to Kitalale Junction in Kinyoro centre. The road rises from 1755-1809 m ASL at Kinyoro centre. The road is generally covered with vegetation. At 5.6 km to 6 km on height of 1768-1773 m above sea level there was no data recorded due to large existing gullies.

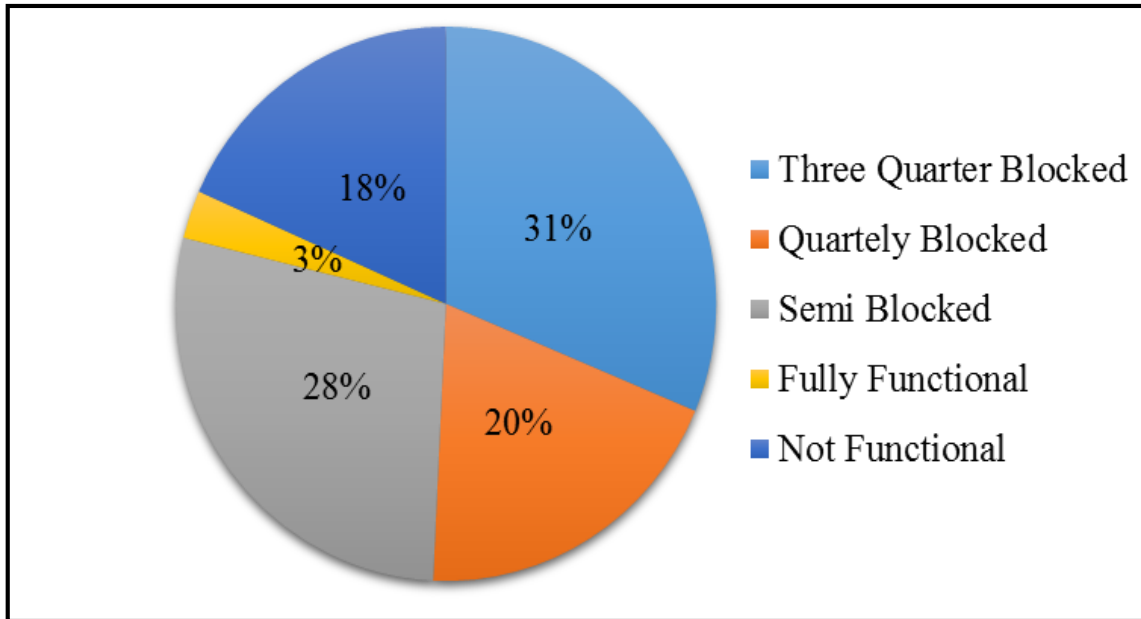
**Figure 4.17: General Road culverts functioning.**

Eighteen percent of the culverts were not functioning at all and they were shattered and completely out of order (Figure 4.17).

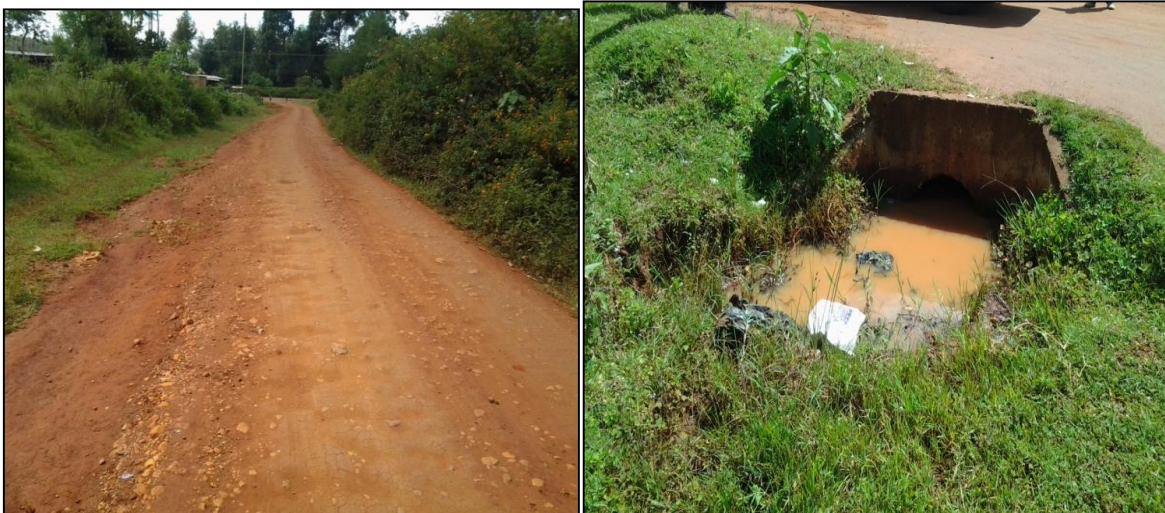
Vegetation encroached the road and distorted the camber resulting to storm water running on the carriage way. Construction of feeder roads joining the road was the major cause of soil erosion. The side drains were covered with grass (Figure 4.18).

**Figure 4.18: Sibanga-Kesegon road at 0+000 km left and right a blocked culvert at Sibanaga-Kitale Junction. Author (Source 2013).**

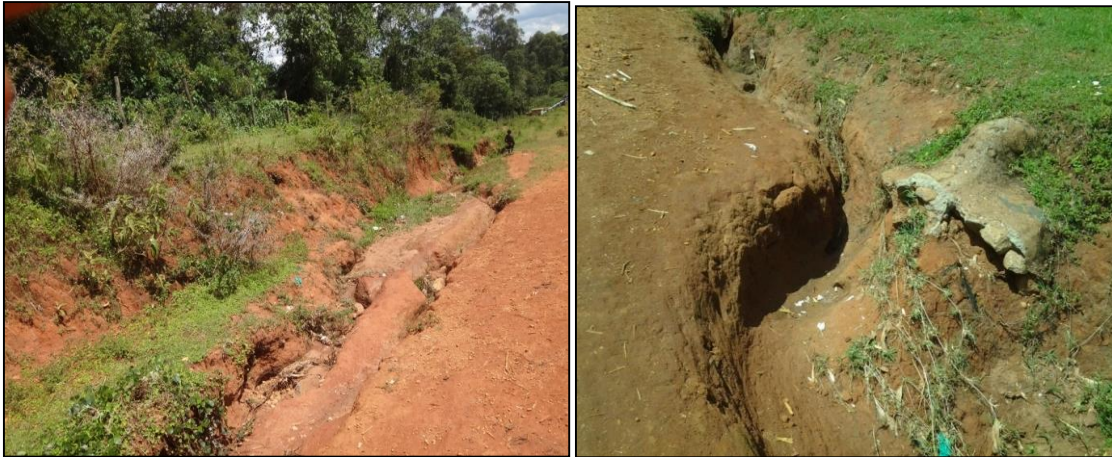
Land ascent was experienced after 3+100 km and the slope faced south. Culvert at 3+400 km was fully blocked (entrance to Sinyeriri School). A series of 5 concrete score checks at 3+800 km had failed and thus partially functioned. The score checks were on the left side of the road oriented towards the North and were distorted with water diverting to the road. Some score checks' aprons were fully eroded and damaged, at 3+900 m there were deep gullies caused by failed score checks on the upper side of the road. (Figure 4.19). The soil was silt quick sand which easily got washed away by water.

**Figure 4.19: Gully erosion (left) and a failed scour check near Saiwa swamp (right). Author (Source 2013).**

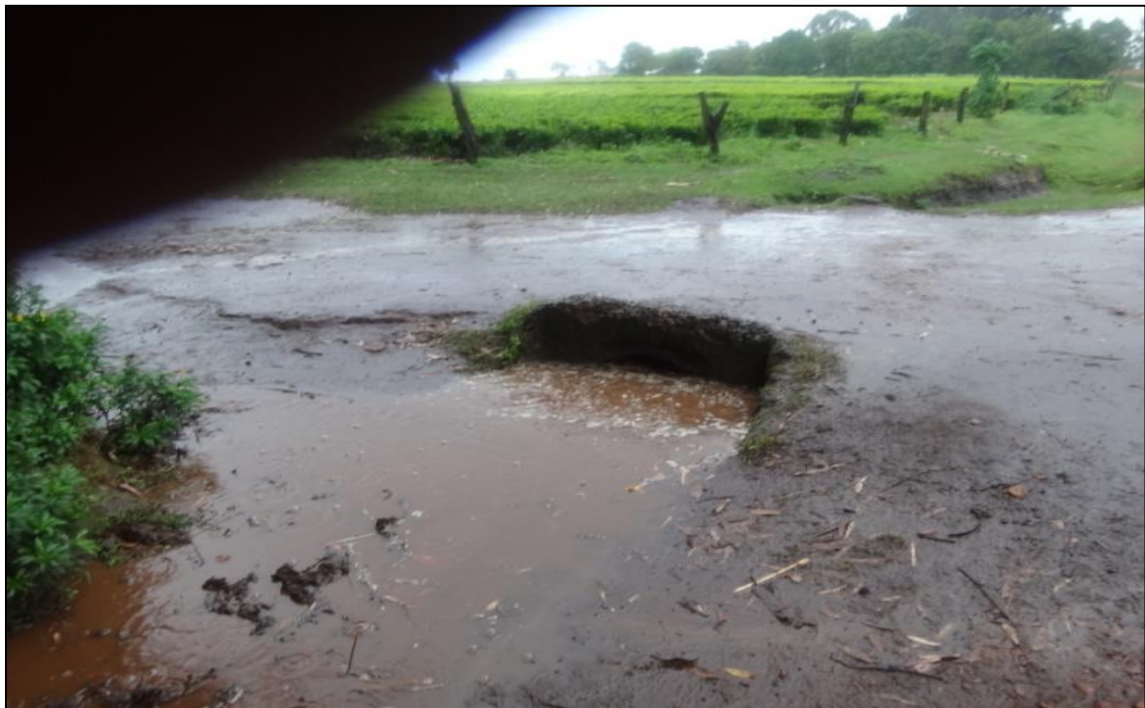
At 8+900 km a culvert was fully blocked on the inlet and 75% blocked on the outlet. The road had a good camber that sloped to the North with good vegetation composed of grass along the side drains. There were eroded side drains at 13+100 km on the south facing slopes. The side drains on most sections of the road were narrow and this was the major cause of road camber erosion by storm water as a result of incapacitation to pass water to the mitre drains or to a relief culvert (Figure 4.20).

**Figure 4.20: Blocked Culvert during Rainy season at Kapchorwa tea factory Junction. Author (Source 2013).**

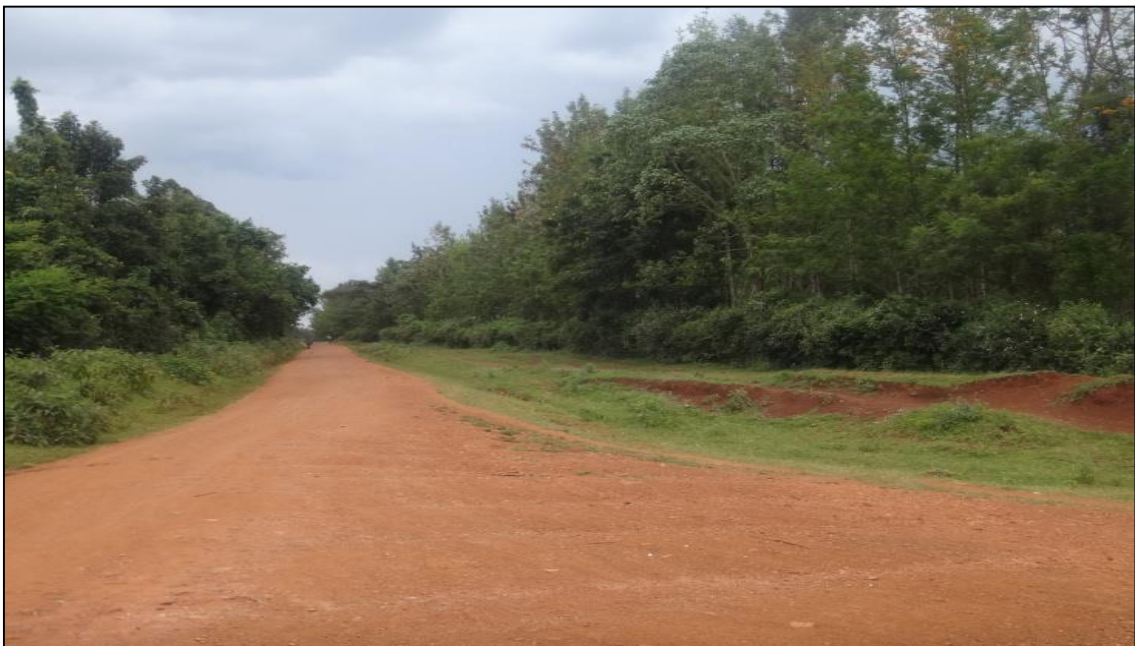
The road started at GPS coordinates  $0^{\circ} 56' 54.099''$ ,  $34^{\circ} 54' 29.8902''$  at the junction leading to Saboti (Figure 4.21). There was no culvert on the junction since it was a flat ground. The side drains were blocked with patches of gravel on the road, grass and shrubs. At 0+100 km, an access culvert to the left was blocked hence diverting the storm waters to the main road. The road shoulders were clear with small vegetation growth. The side drains ditches at 0+500 km were fully silted with no vegetation cover.

**Figure 4.21: The carriage camber at Sibanga-Saboti Junction. Author (Source 2013).**

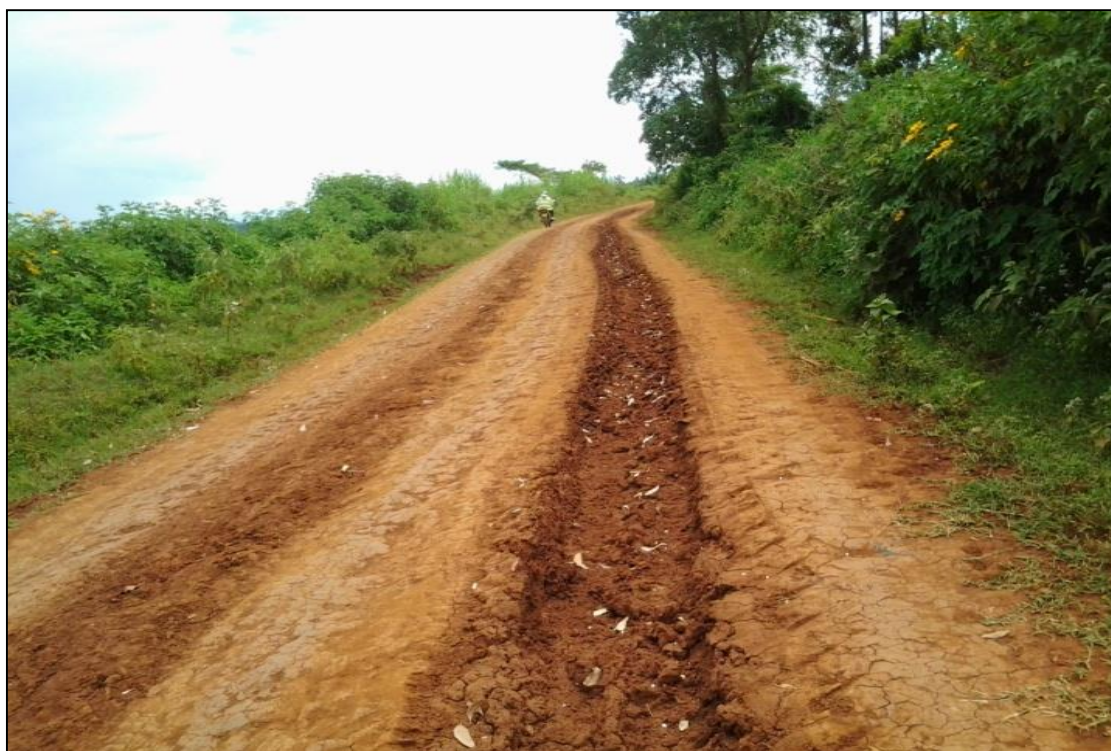
After the junction at 2+900 km the road became narrow with no gravel. The drainages were not well maintained and the slope was towards North West. At 5+ 400 km the road crossed river Kiminini which was in a dilapidated state and no defined drains that directed water into the river. The sides of the road were also worn out thus distorting the road camber from the East when ascending to the North.

**Figure 4.22: Distorted road camber near Kijana Wamalwa Sec School. Author (Source 2013).**

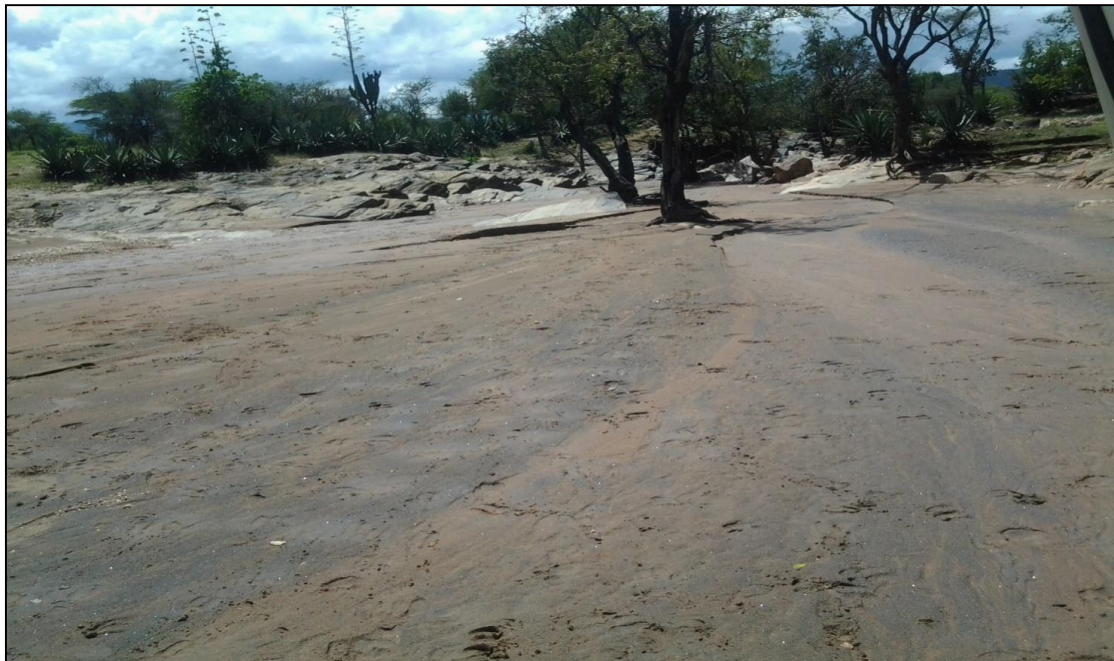
There was short grass, well defined camber and the mitre drains were filled with sediments at 0+100 m. At 0+150 m there were deposits of sand along the road. The mitre drains were blocked by adjacent land owners making it difficult to drain water off the roads.

**Figure 4.23: Silt deposits on Road camber 500m from Naskuta Primary School. Author (Source 2013).**

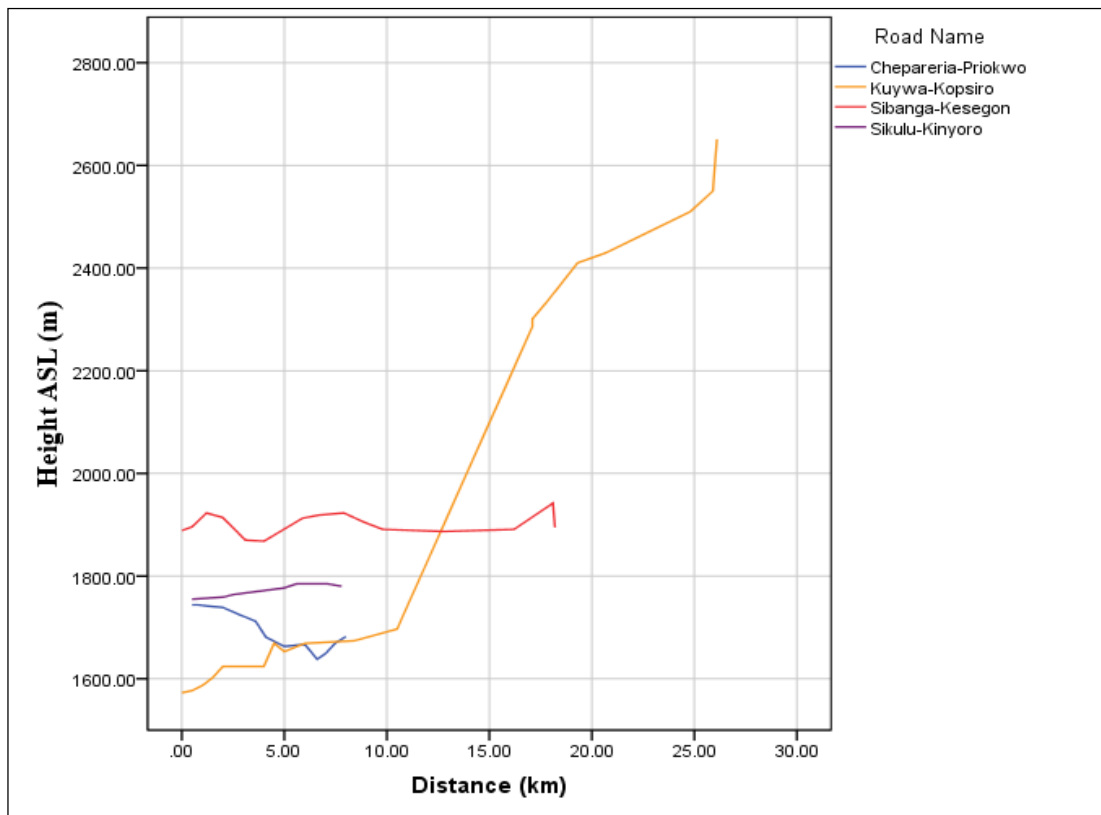
**Figure 4.24: General study Roads profile.**

The general road profile of the study roads, after plotting the height above sea level, altitude against distance of the road provided the following output (Figure 4.24).

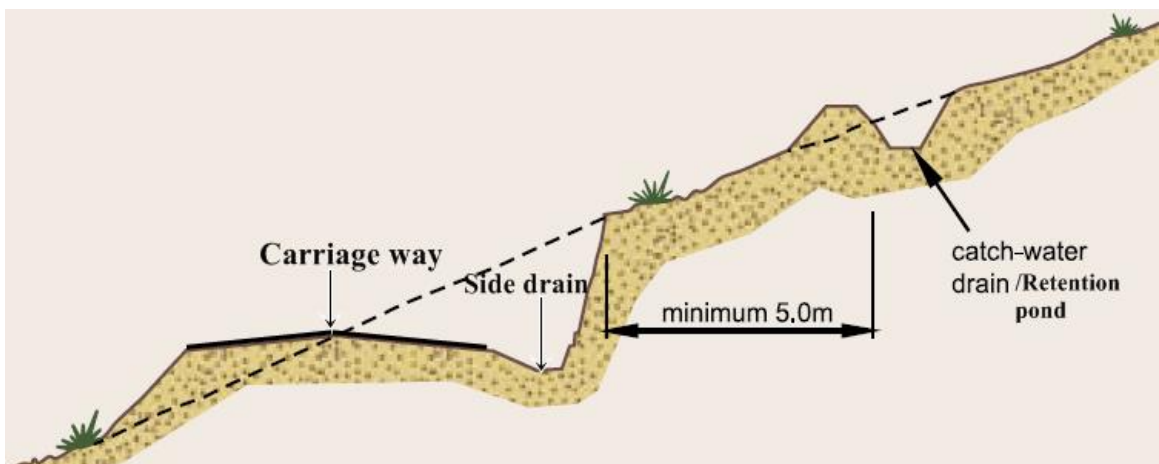
**Cross-section of catch drain location on hilly roads. Adopted from: ILO.org 2013 and Ministry of Roads Handbook.**
