**MAPPING LANDSLIDE SUSCEPTABILITY ALONG THE NANDI
ESCARPMENT IN KABRAS DIVISION,
KAKAMEGA COUNTY, KENYA**

**A THESIS SUBMITTED TO THE SCHOOL OF ENVIRONMENTAL STUDIES IN
PARTIAL FULFILMENT FOR THE REQUIREMENT FOR THE DEGREE OF
MASTER OF SCIENCE IN ENVIRONMENTAL STUDIES (ENVIRONMENTAL
INFORMATION SYSTEMS)**

UNIVERSITY OF ELDORET, KENYA

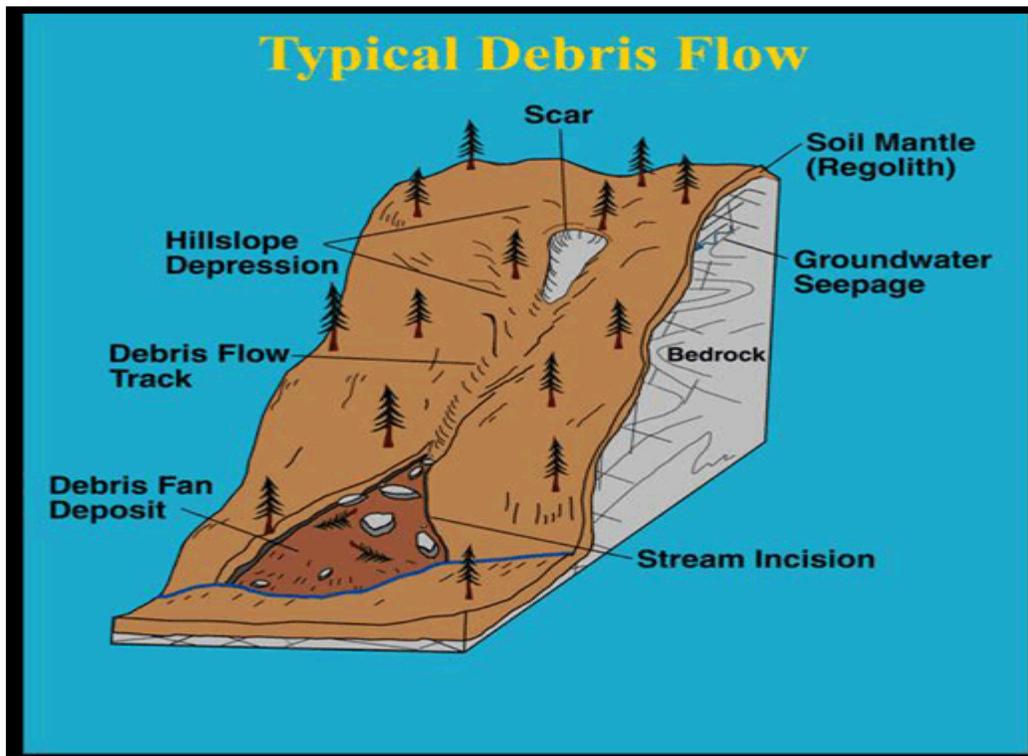
Figure: 2.1 Schematic of typical hillslope setting for debris flows.

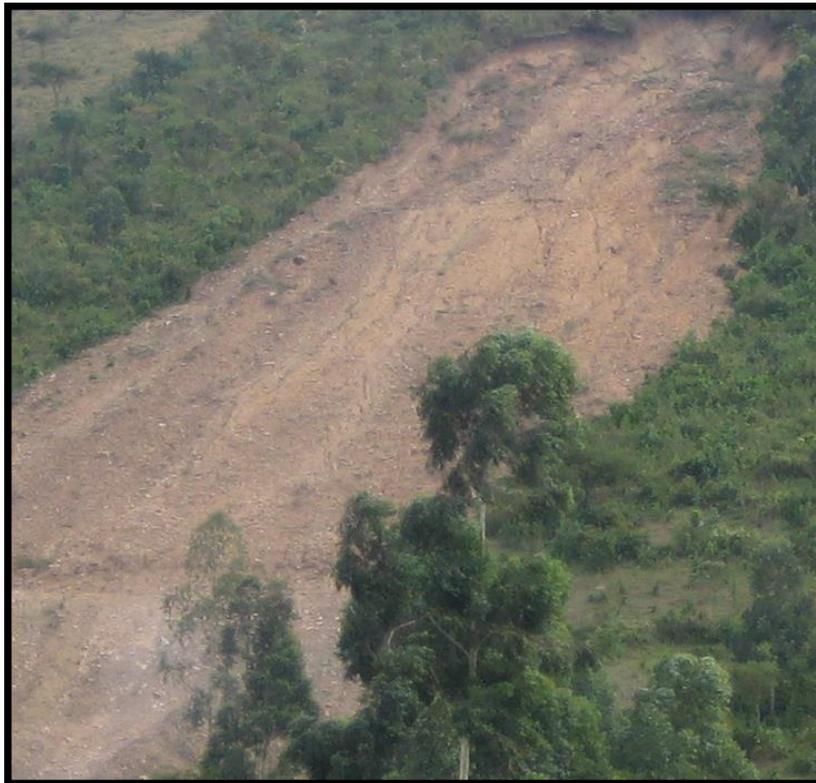
Plate 2.2 Khuvasali Slope Failures which occurred on 11, August 2007, Length-200m, width- 100m, and gradient - 35° (Source: Author, 2008)

A fresh landslide scar was observed in the area of study (Plate 2.2). When the residents were asked what might have caused the slide, majority said heavy rains had pounded the area for three consecutive days. Another smaller landslide had occurred some few meters ahead where rocks and soil flowed to the road causing its closure. The local people's perception indicates that rainfall amounts and intensity are generally higher than they were in the previous years.

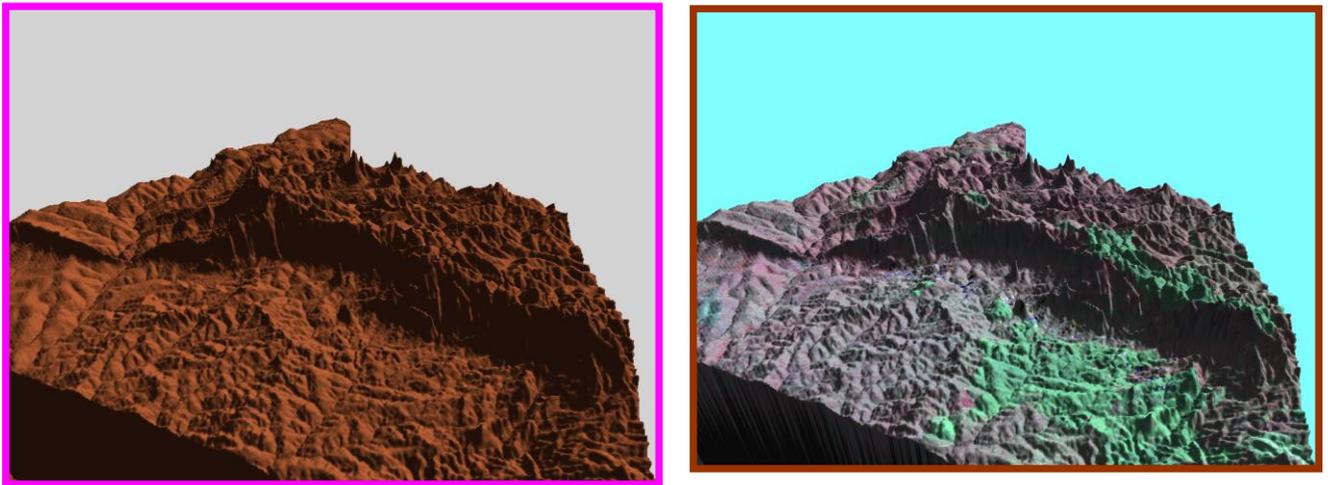
Plate 2 indicate the area of interest in 3 dimension view while Plate 3 is DEM that was draped on pansharpened Landsat ETM 2006 to allow further visualization. (Source: Author, 2008)

In Erdas, the grid image was draped so that it could be viewed in 3D (DEM). The 2006 Landsat ETM+ was pansharpened since it had the panchromatic band eight, then it was overlaid on the draped DEM to allow for visual interpretation (refer to plate 2 and 3).

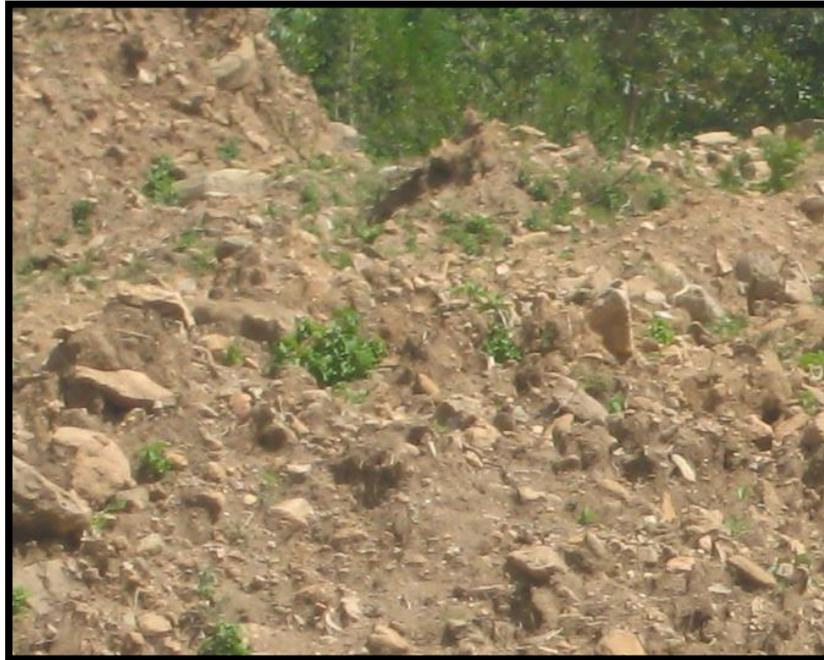
PLATE 4.1 High amounts of gravel and stones in soil within the landslide scar in Khuvasali village (Kabras). (Source: Author, 2008)

From the pictures taken it is evident that the area has a high content of boulders, stones and gravelly clays as show in (Plate 4.1). The soils remain unconsolidated; also their water holding capacity is very high because of presence of sand and clay material in it. Thus it is evident that the area is highly susceptible to landslides other factors held constant.

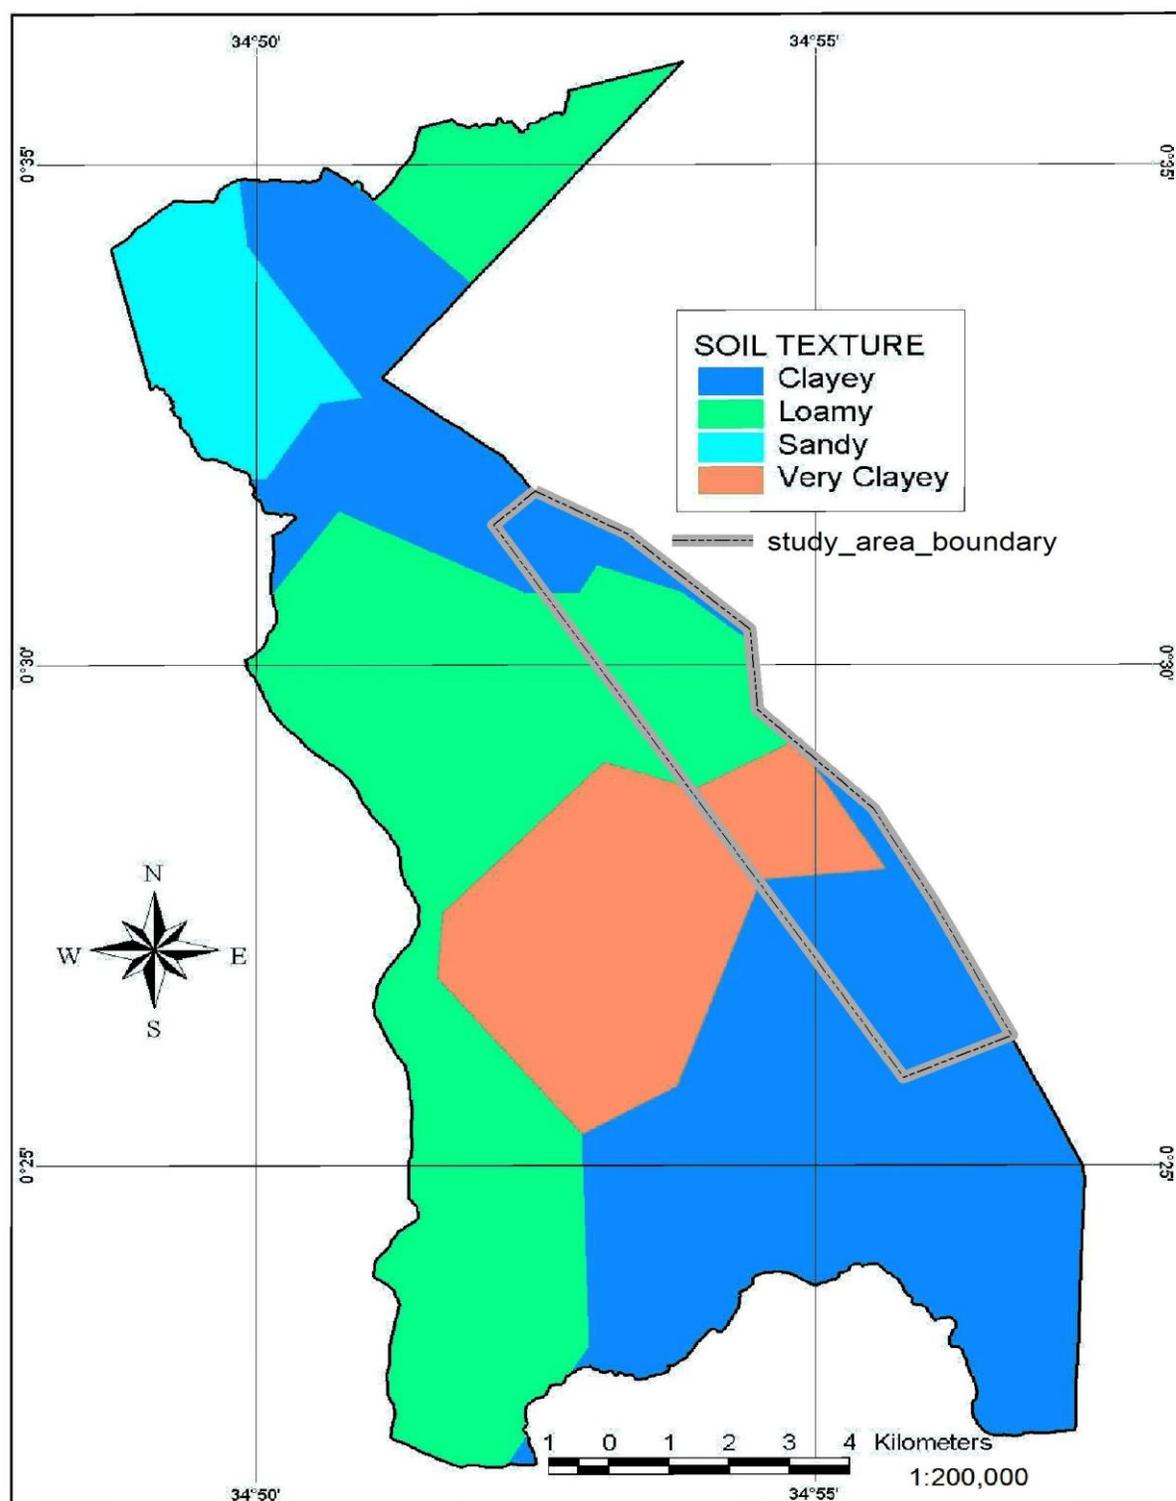
Figure 4.1: Textural Classification of the Soils of the Study Area.

Ranks	Soil texture	Susceptibility
1	Very clay	Very high susceptibility
2	Sandy	High susceptibility
3	SandyLoam	Moderate susceptibility
4	Loamysand	Low susceptibility

Thus, the Soil map has got four categories and based on textural classification.

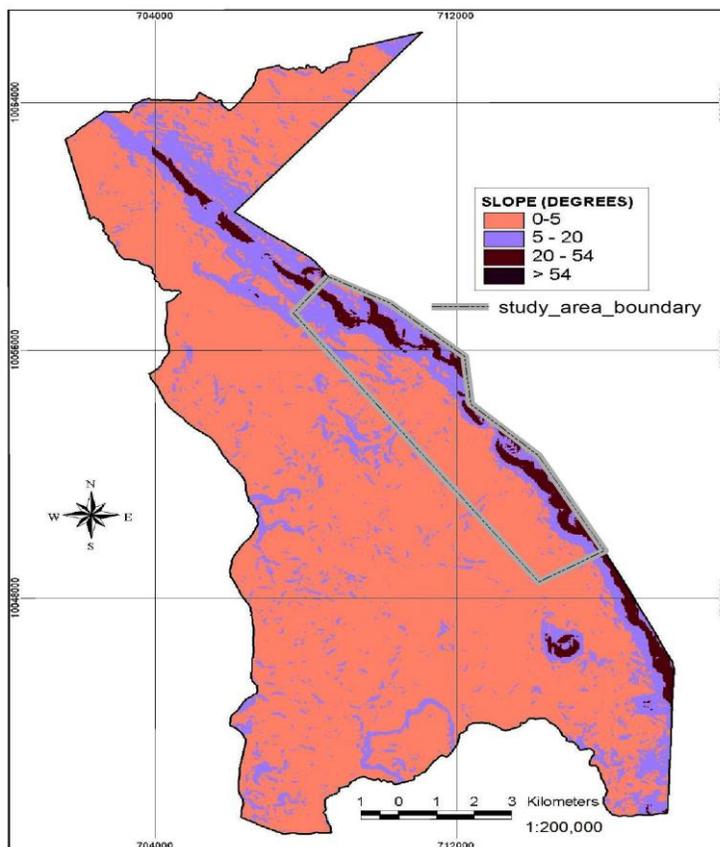
Figure 4.2: Slope Map derived from contours digitized from topographical map 1:50,000, modified. (Source: Author, 2008)

was used then slope was automatically generated after activating the ‘Derive surface tool’ and a slope map covering the AOI was obtained (see Figure 4.2)

Rank	Slope degree	classification	Susceptibility to slope failure
1	$> 54^{\circ}$	very steeply sloping	Very highly susceptible
2	$20^{\circ} - 54^{\circ}$	steeply sloping	Highly susceptible
3	$5^{\circ} - 20^{\circ}$	moderately sloping	Moderately susceptible
4	$0^{\circ} - 5^{\circ}$	Flat - gently sloping	Low susceptibility

Thus, the slope contour map has got four categories and suitable ranks were assigned.

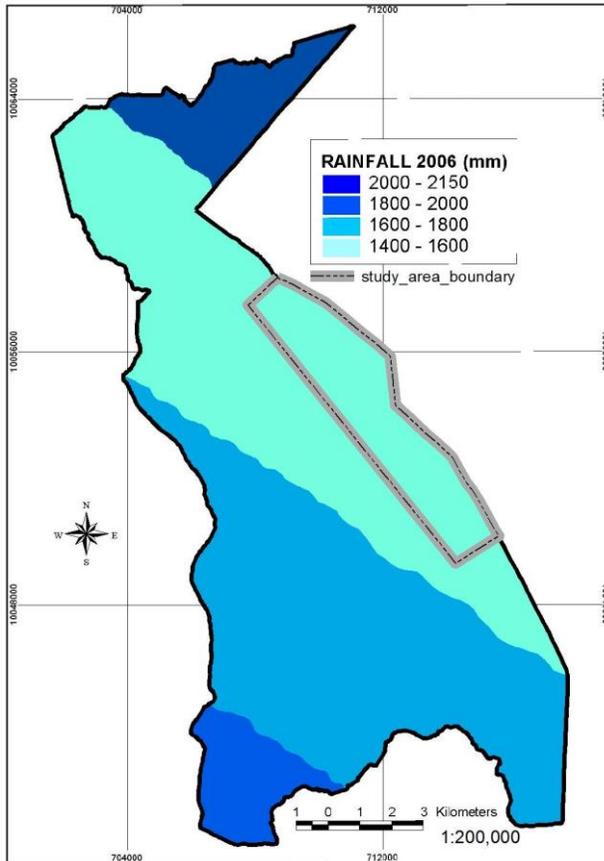
Figure 4.3: Rainfall Distribution Map of the Study Area isohyets; derived using data from 12 weather stations from 1985 to 2006. (Source: Author, 2008)

Areas that receive over 2000 mm of rainfall annually are likely to experience landslide. When rainfall is high and well spread, the probability of high infiltration rate is high. Increased infiltration and percolation of rain result in increased soil moisture and hence high pore pressure. It is after a long duration of soil moisture accumulation that the pore water pressure builds up to a critical state where all other factors held, sliding is inevitable (Gray, 1970).

Areas which receive less than 1400 mm are less susceptible to landslides (refer to Figure 4.3). No landslides will take place unless pore water pressure reaches a critical point whereby soil particles can no longer withstand shear stress.

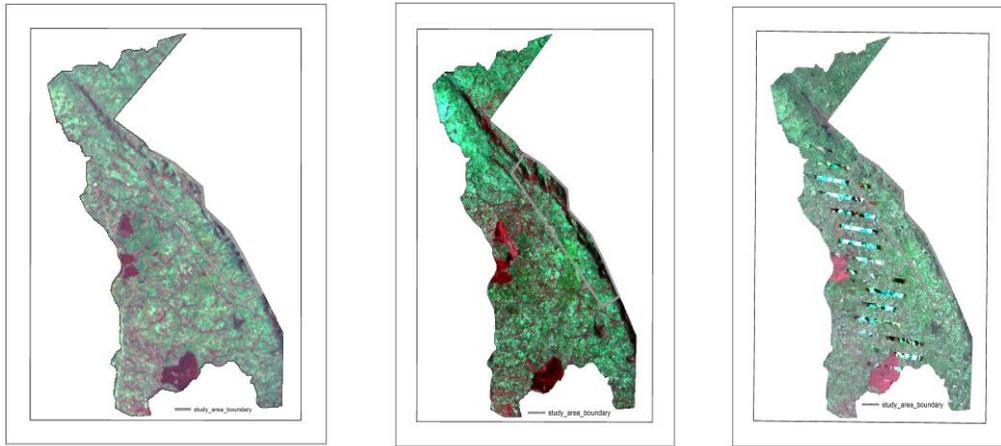
Figure 4.4 LANDSAT IMAGES (False Colour Composite, Band 4Red, 3Green, 2Blue showing landuse change for the years 1973, 1995 and 2006 respectively). (Source: Author, 2008)

After only 11 years, it was observed that there was a drastic LULC change in the 2006 Landsat ETM image in which there was a further decrease in the forest cover. Increase of human settlement on the escarpment accompanied by intensive large scale farming. This was also evident in the satellite image (false colour composite) from regular shaped pink/light red colour parcels of land. It was evident by people living in on very sensitive area as high as 35° - 40° which can lead to slide when all factors for landsliding are met (Plate 4.5). It is also evident that the forest cover has reduced drastically as compared to the 1973 image/map. The forest that covered the escarpment had been cut down to provide very productive farmlands; this was attributed to fertility of the “virgin” soil. There was high demand for timber to be used in the Webuye Paper Factory. This led to increase in the rate of tree felling for commercial purposes (refer to plate 4.6). There was also high demand from the Mumias Sugar Factory which accelerated tree felling along the escarpment for sugarcane farming.

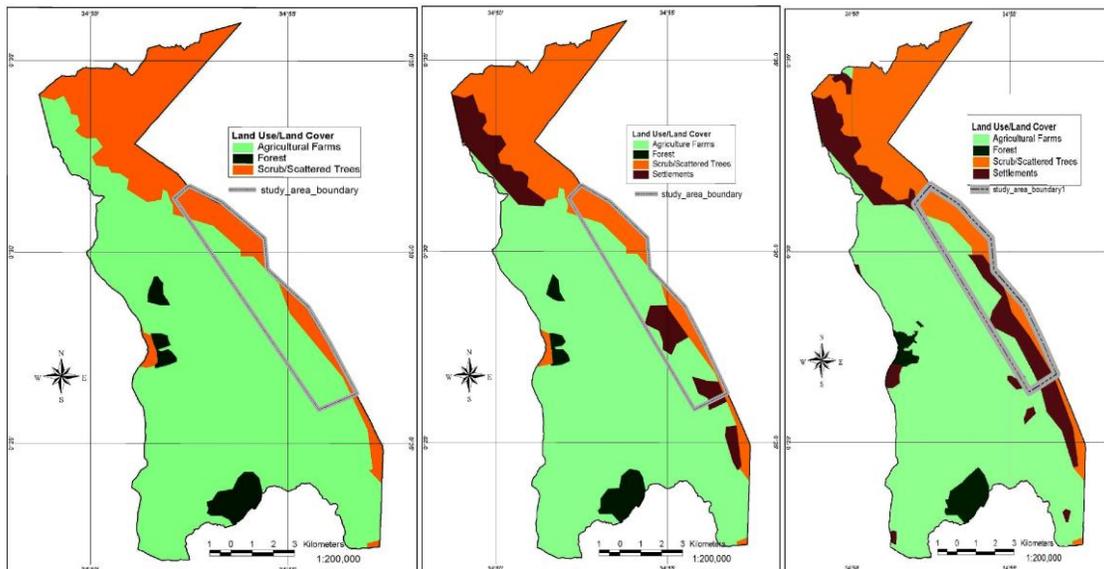
Figure 4.5: Land use/ Land cover Maps (1973, 1995, and 2006 respectively). (Source: Author, 2008)

Land use/land cover of an area has direct or indirect influence in triggering the slope failures. Different types of land use /land cover types were identified in the study area such as settlements, agricultural farming, forest, shrub and grasslands (Fig 4.5)

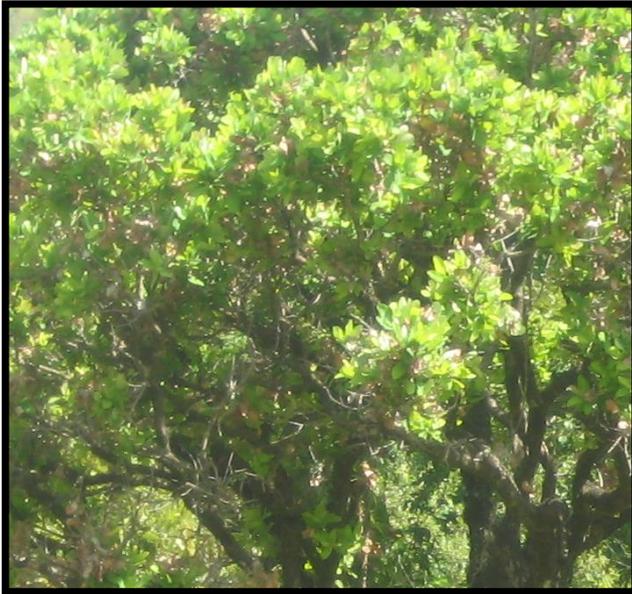
Plate 4.2: Indigenous Vegetation from the slopes of Khuvasali. (Source: Author, 2008)

Originally the Nandi Escarpment was covered by natural vegetation (forest) made up of indigenous trees (Plate 4.2). (“*mulomonyo*” “*Musyoma*” “*Musangula*”) shrubs and grasslands. At the time of this study some part of the escarpment was already exposed after cutting down of trees for cultivation. Vegetation cover was made up of cypress (exotic vegetation). This was also seen in the image as it appeared dark red in the false colour composite. Though the satellite image Landsat TM of 1973 had very low resolution and hence prone to errors it was treated cautiously. It was also evident from the landuse /landcover map, (Figure 3), that, there was no human settlement on the Nandi Escarpment and the area was then colonized by grasses, trees and bushes in 1973. From the interviews conducted, there was no report of landslide in the area except one in 1973 which resulted from heavy down pour. Forest trees and dense undergrowth tend to stabilize the soil because the tree root-system acts to increase the shear strength of the soil, thus preventing occurrences of slope failures. There was subsistence farming practiced but it was not intense as of today, thus there was no overworking and overloading on the escarpment hence no landslides.

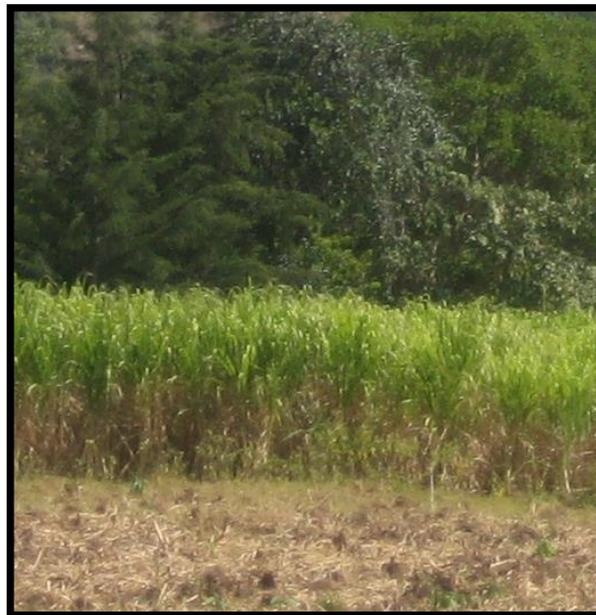
Plate 4.3: Small Scale Sugarcane Plantation at the foot slopes of the escarpment. (Source: Author, 2008)

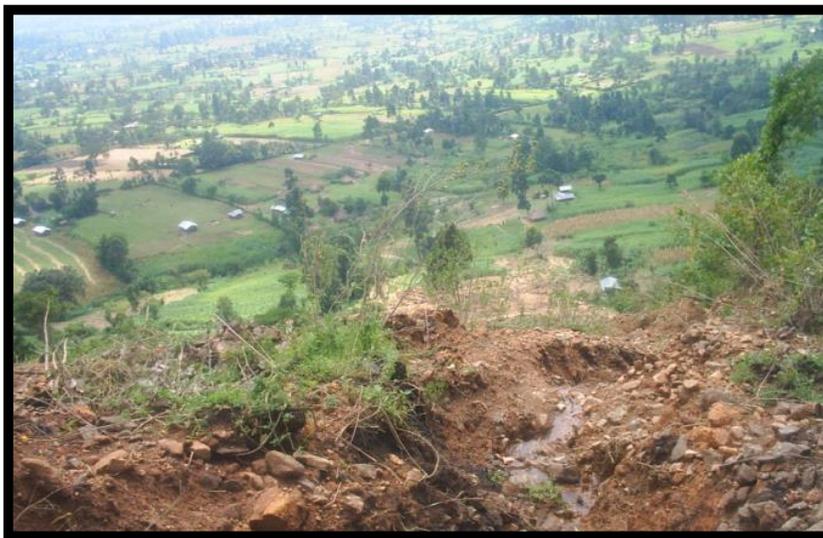
PLATE 4.4: Intensive farming along the Nandi Escarpment enhances slope failure.
(Source: Author, 2008)

During the Population and Housing Census 1999, Kakamega North Sub-County had a population of 603,422 with an annual growth rate of 2.12 per cent, compared to 488,352 in 1989, representing a growth rate of 2.98 per cent per annum. By the end of the plan period the population would have increased by 21 per cent. Republic Of Kenya, (2002-2008). High population density leads to clearance of forest and settlement on slopes which makes them unstable and can result in occurrence of landslides. Satellite image of 1973 showed that there was no human settlement in the area before but the 2006 image showed that the escarpment has been inhabited. This means that the escarpment has been encroached. Field observation also revealed that there are human settlements on the Escarpment as steep as 55° by terracing for construction of houses (Plate 4.4).

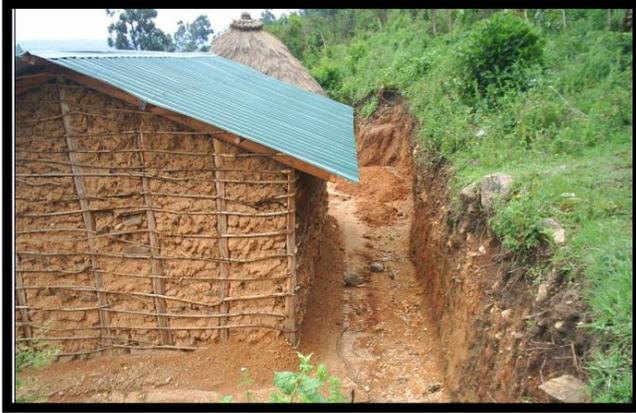
Plate 4.5: Steep hillslope modification by human Settlement enhances slope failure.

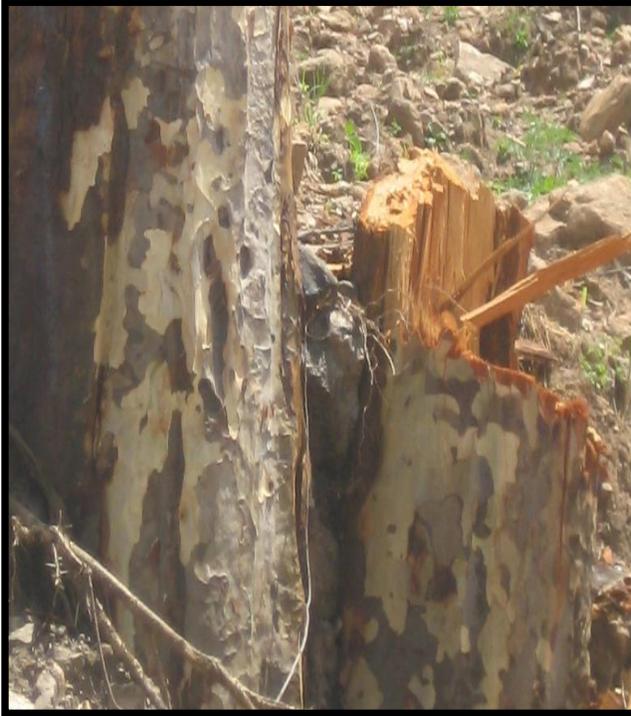
Plate 4.6.1 Cutting down of deep rooted Eucalyptus Trees which enhances slope failure on the escarpment. (Source: Author, 2008)

The observation also showed that people in the area cut down deep and long rooted trees and instead plant shallow rooted trees like cypress and pine trees on the escarpment. Cypress trees have short and shallow roots (Inganga, 1995); thus the short roots cannot be used to increase shear strength of the slope material as in the case of eucalyptus. Also cypress cannot seep water from the escarpment in form of rain or springs that flow down slope. Thus they make the area more susceptible to landsliding.

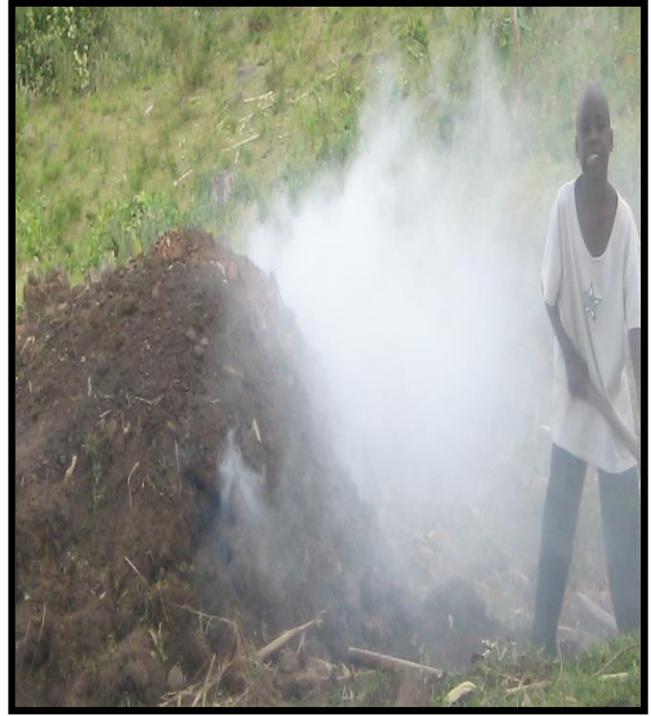
Plate 4.6.2 Charcoal burning a major cause of deforestation which enhances slope failure on the escarpment. (Source: Author, 2008)

Most of the charcoal is sold to urban dwellers within Malava town and the rest to dealers who transport most of it to larger urban areas like Eldoret, Webuye, Kakamega and Bungoma. Despite the financial gains accrued, the practice has contributed to accelerated tree depletion in the Nandi Escarpment.

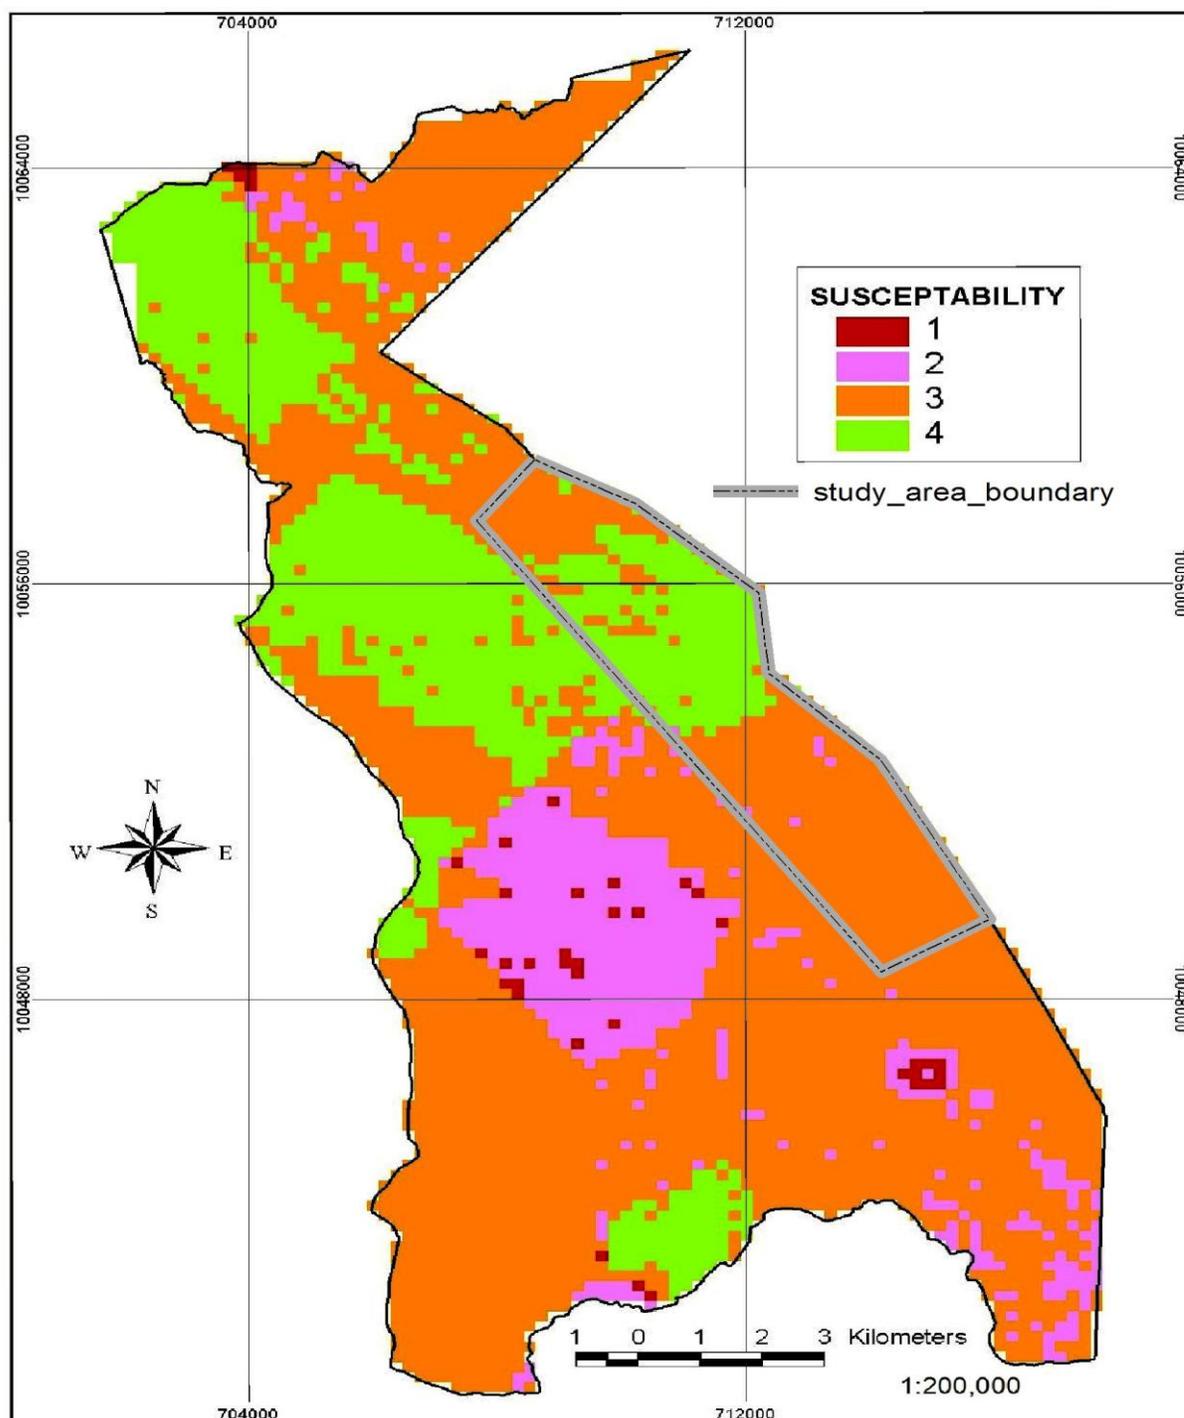
LANDSLIDE SUSCEPTIBILITY MAP OF THE NANDI ESCARPMENT ALONG KABRAS DIVISION.

Figure 4.6: Landslide susceptibility map of the study area. (Source: Author, 2008)

Thus the landslide susceptibility map indicates the whole study area was divided into four zones/classes as shown in Figure 4.6
