**IMPACTS OF FLUORSPAR MINING ON THE PHYSICAL ENVIRONMENT: A  
CASE STUDY OF KIMWARER AREA KERIO VALLEY, ELGEYO-  
MARAkwET COUNTY, KENYA**

**A THESIS SUBMITTED TO THE SCHOOL OF ENVIRONMENTAL STUDIES IN  
PARTIAL FULFILMENT OF THE REQUIREMENTS FOR THE DEGREE OF  
MASTER OF SCIENCE IN ENVIRONMENTAL STUDIES. UNIVERSITY OF  
ELDORET, KENYA**

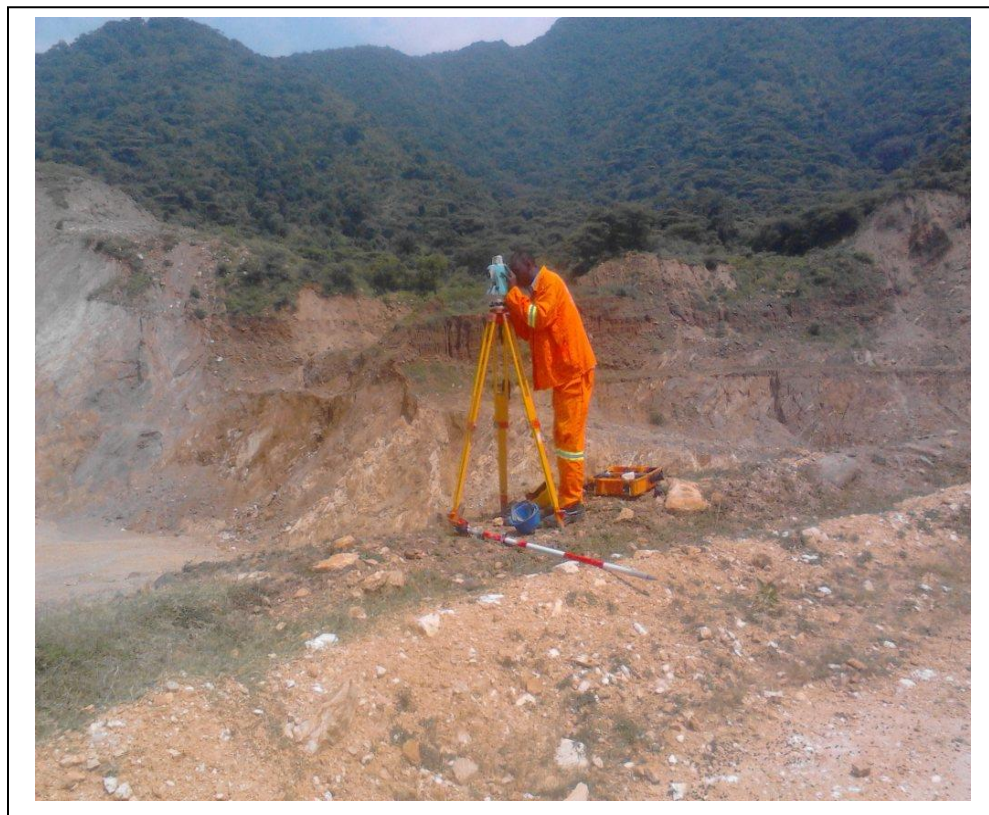
**Plate 1: Total survey station on a tripod used for survey in the field. Data collected is the elevation and location points used for the calculation of area and volume (Source: Author 2013)**

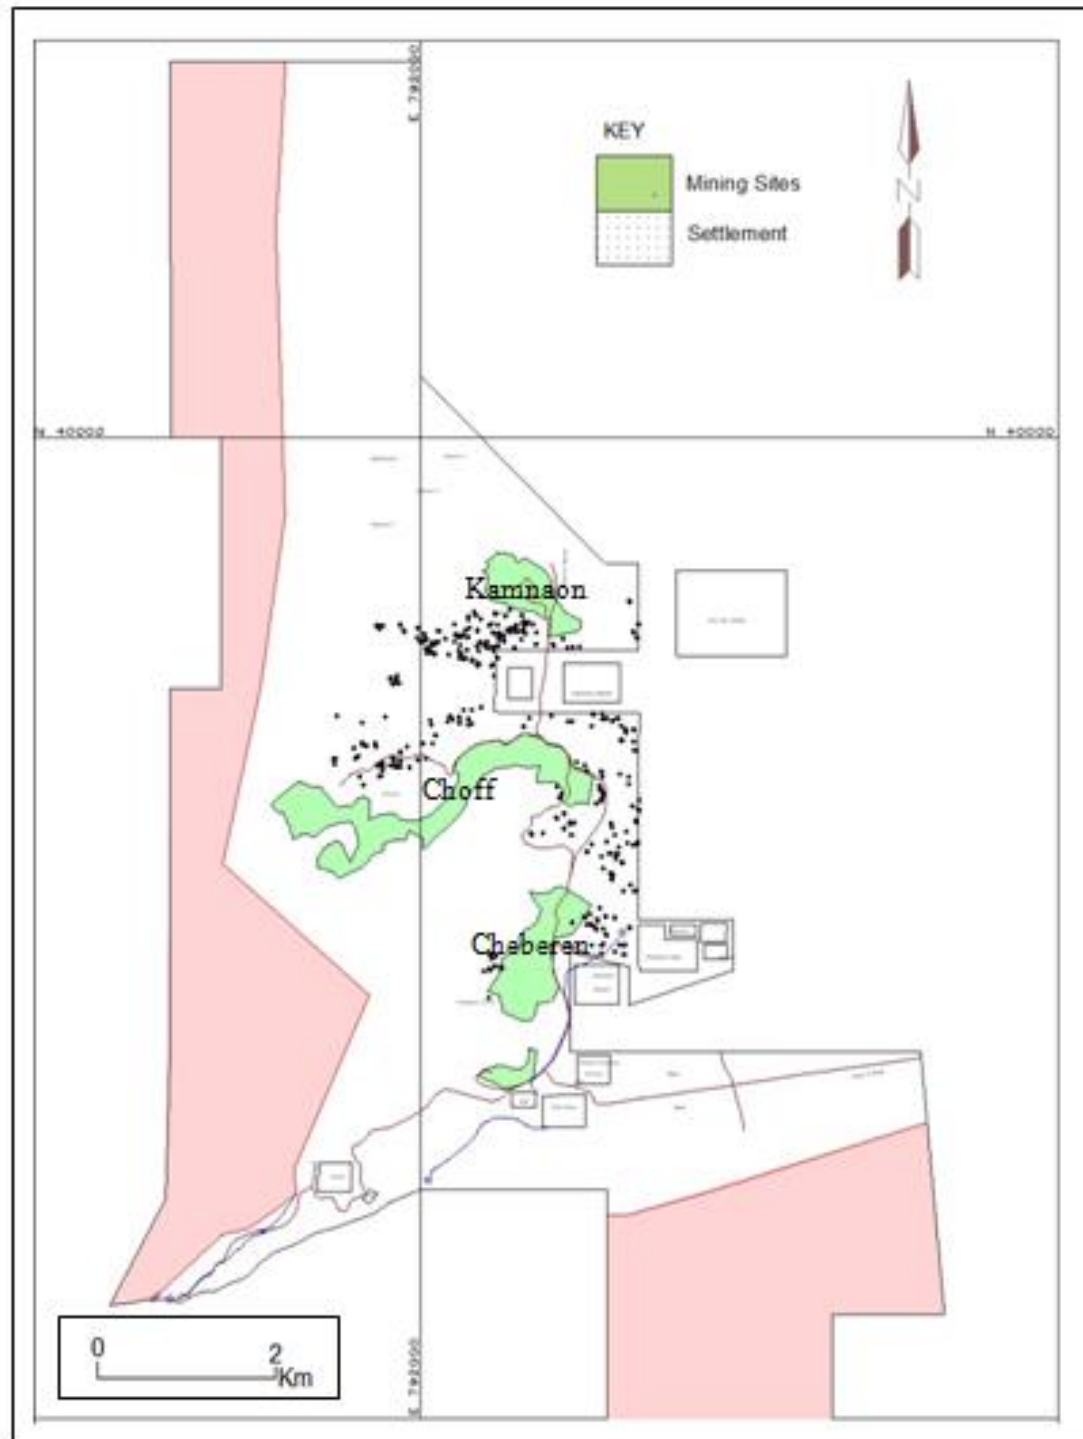
**Figure 10: The three major fluorite orebodies in Kerio Valley (Source: KFC 2010).**

The fluorite orebodies occur along a tract some ten kilometres long and about three kilometres wide, at the foot of the Elgeyo escarpment, and stretch from Kimwarer ridge to Muskut (Figure 10). That the mineralization (introduction of fluorite, silica, iron ores, etc.) was fault controlled is indicated by its Tertiary age, the parallelism of the line of ore deposits, and the location of the source in the waning phase of an igneous cycle. However, the localization of conformable deposits suggests that replacement of lenticular limestone bodies occurred.

The fluorite orebodies occur in a tract of country some ten kilometers long and about three kilometers wide, lying at the foot of the Elgeyo escarpment, and stretch from Kimwarer ridge to Muskut (Figure 10). That the mineralization was fault controlled is indicated by its tertiary age, the parallelism of the line of ore deposit, and the location of the source in the waning phase of an igneous cycle. However the localization of conformable deposits suggests that the replacement of lenticular limestone bodies occurred (KFC, 2010).

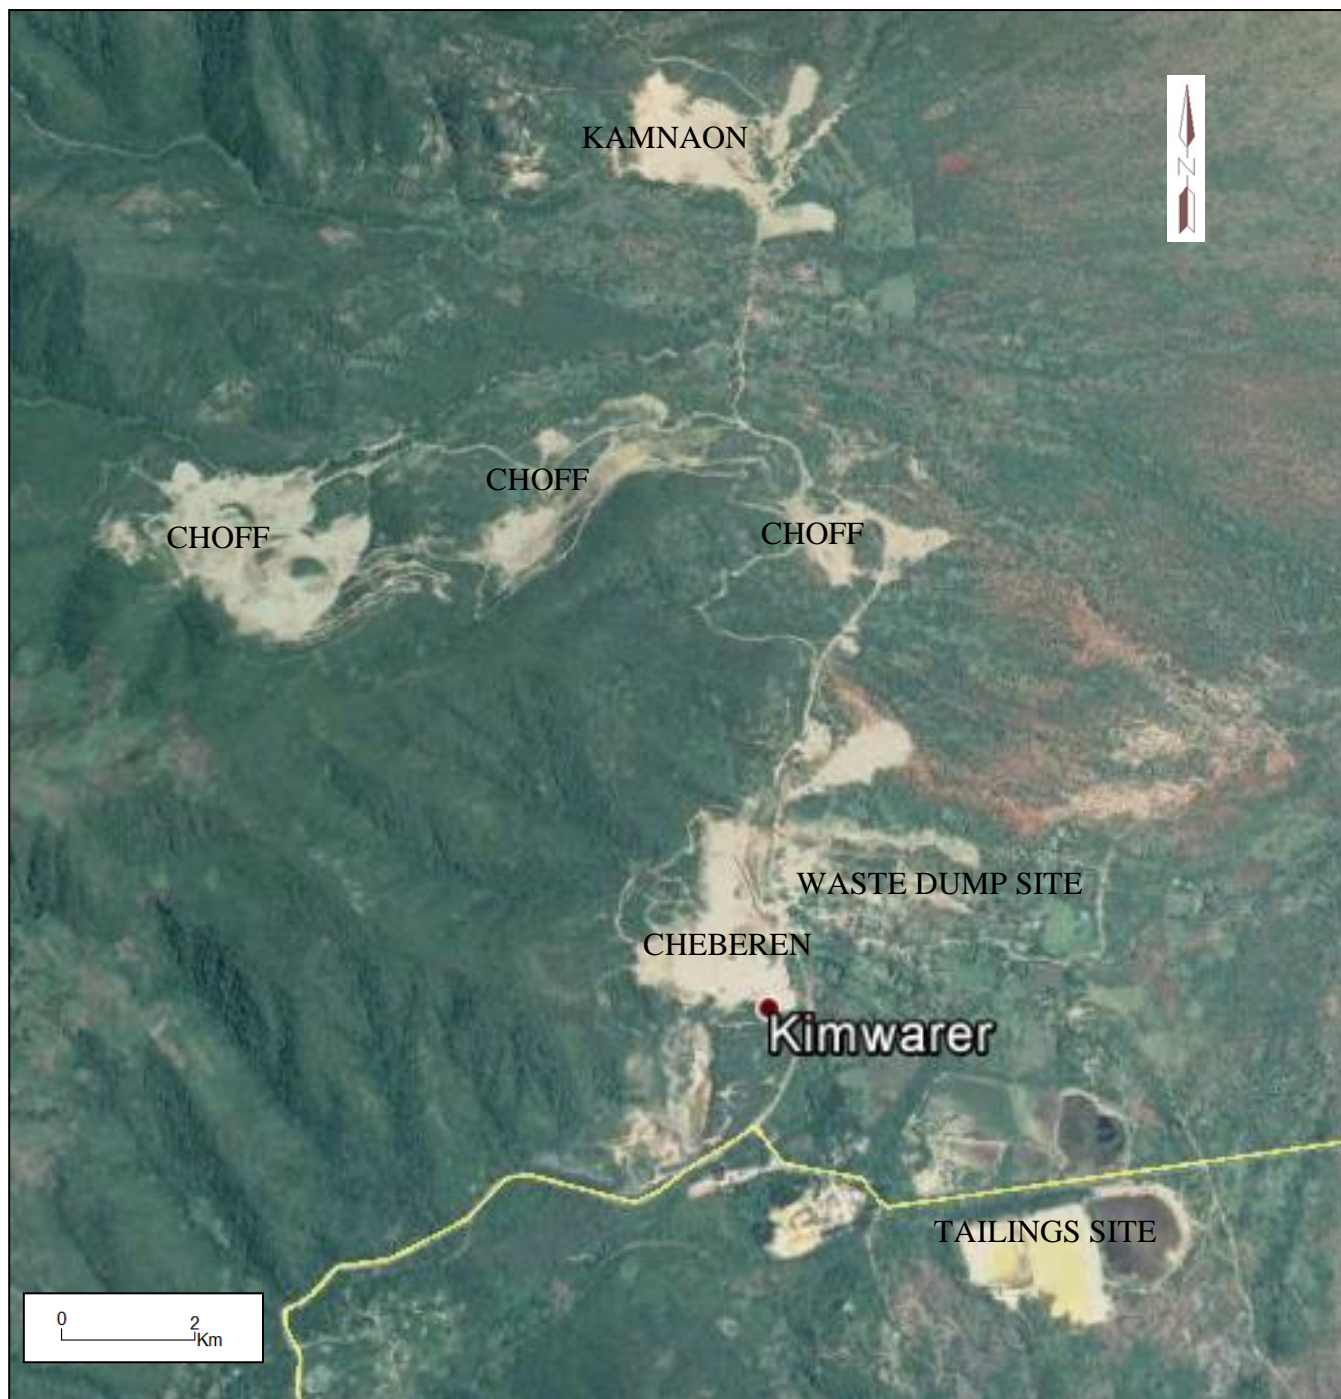
**Figure 11: Google Earth Image representation of the study area. The white patches on the northern section of the map show the mine pits and some section of the dumping site for the wastes. White and brown patches on the south eastern section show the tailings section and water dams (Source: Google Earth 2014).**

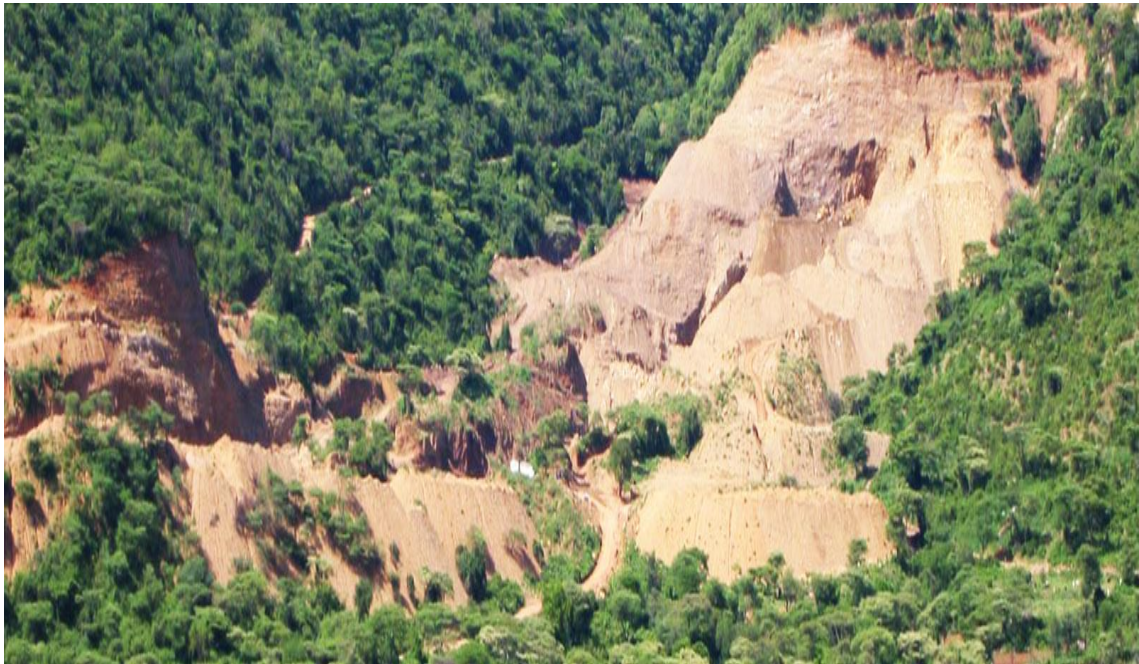
**Figure 14: An abandoned pit after mining within a section of the Choff mining area. Vegetation has started to grow on the flanks of the mined out area (Source: Author 2013)**

hills within the mining area. Figure 14 is an abandoned mine pit signifying a disfigured topography.

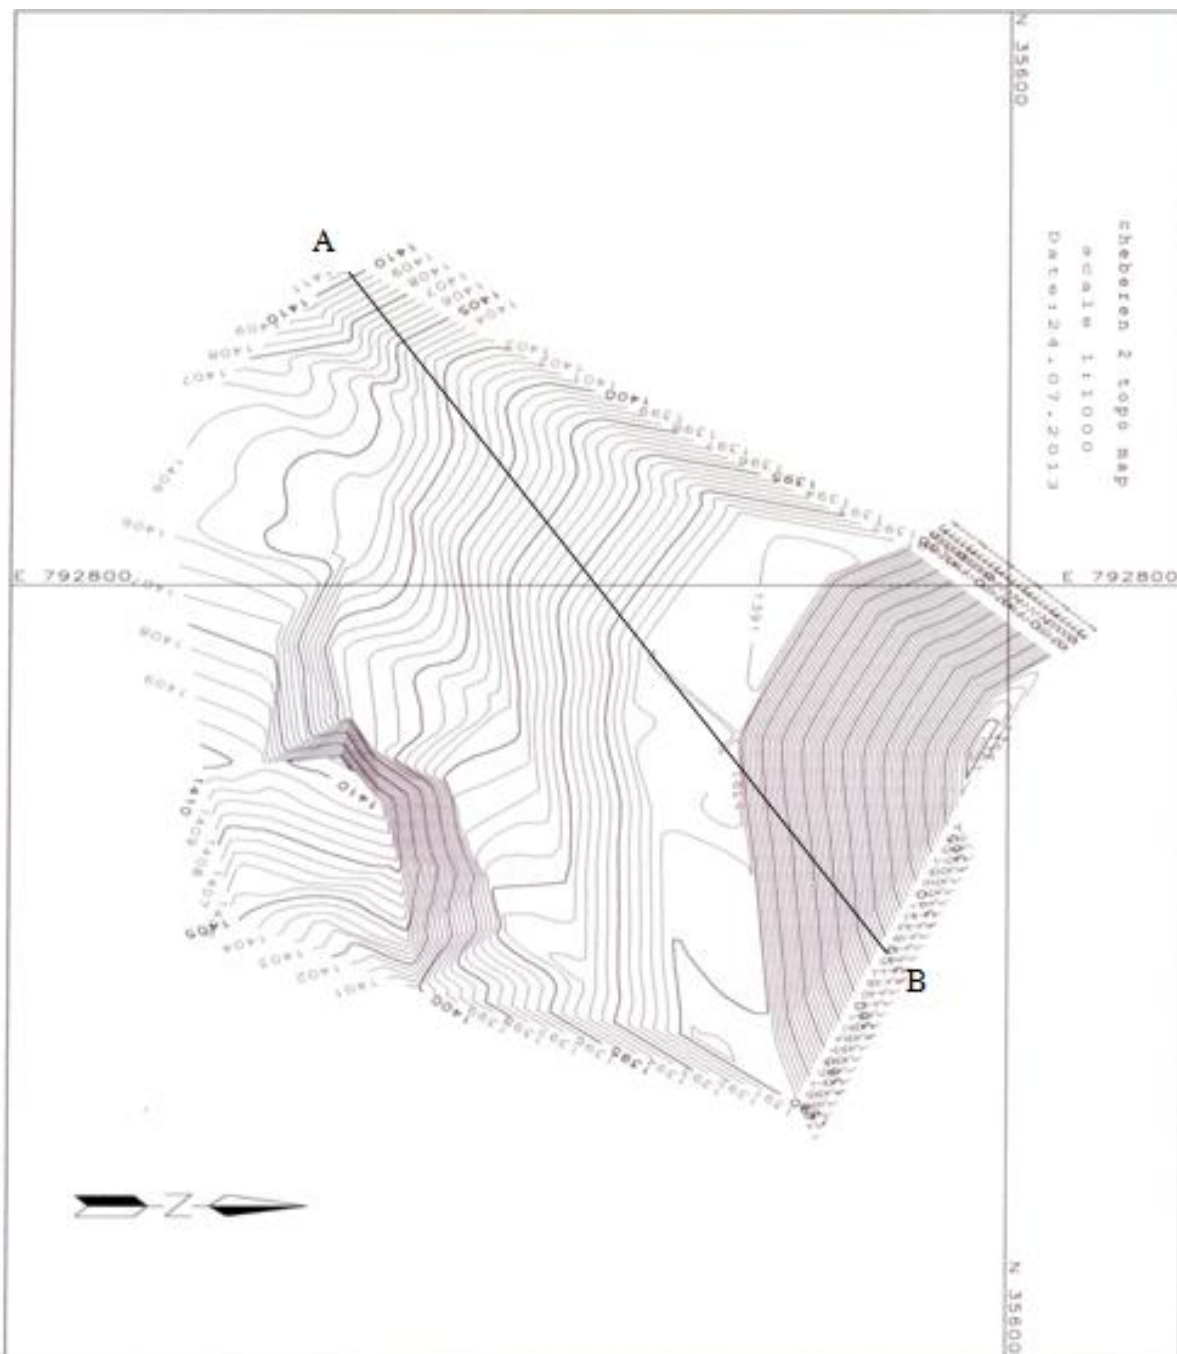
**Figure 15: Contour map for Cheberen Mine in 2013 that was generated to calculate the current area and volume the Cheberen mine pit.**

Figure 15 is a contour map for Cheberen mine site that was generated and Table 4.7 shows the pit area and volume calculated after generating the contour map. The Line A-B on the contour map was used to generate the mining model.

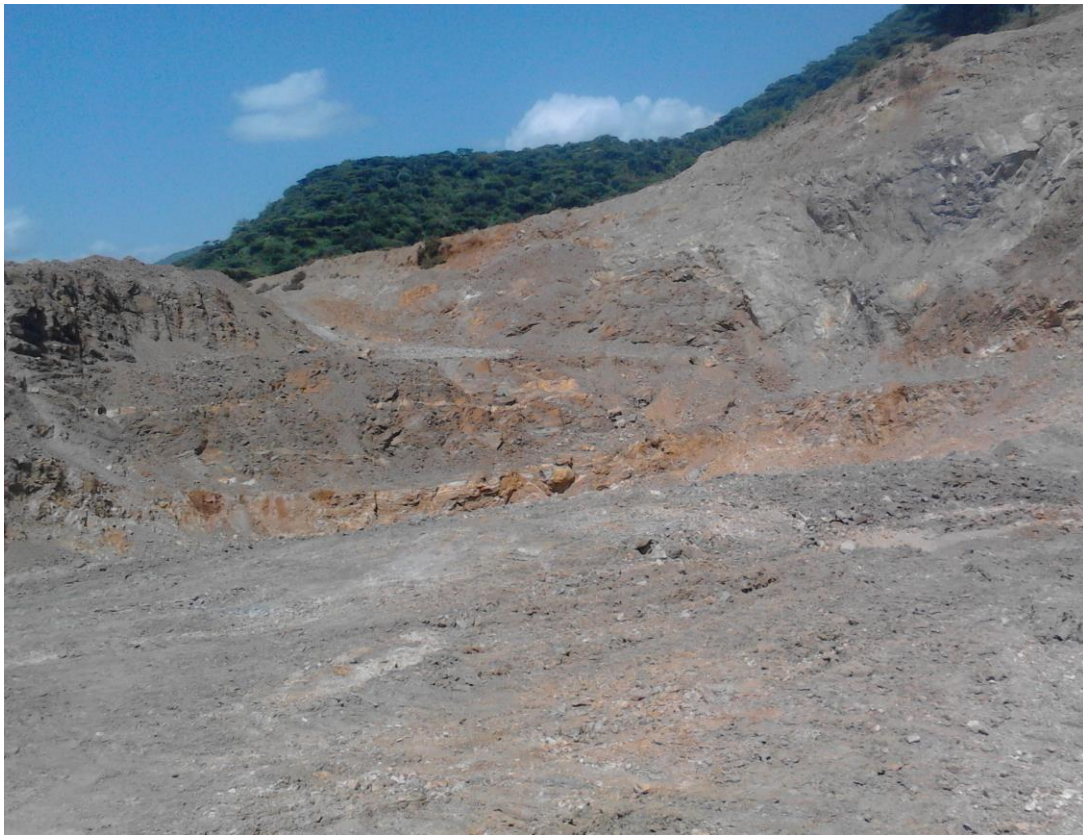
**Figure 18: An excavated pit where ore is extracted, the pits are extended depending on the strike and the attitude of the mineral deposit (Source: Author 2013).**

The change in topography that is evidence of the areas are the open pits such as on figure 18, on the western section of the mines, the waste dumps on the eastern section and the mining tailing piles on the south eastern section.

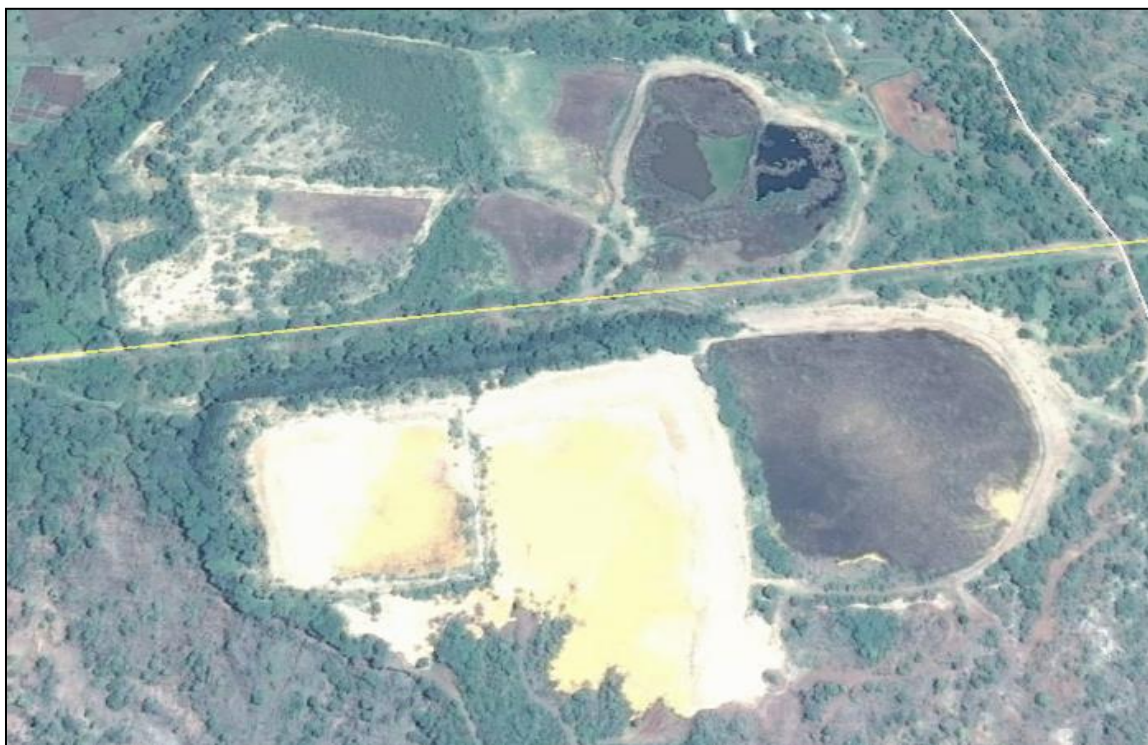
Figure 22: Google Earth Image of the Tailings Dump Site.

There are three tailing dams A, B & C where tailings (slimes) are deposited. When no slimes are deposited on Dam A which is allowed to rest and consolidate. Slimes are deposited on dam B through a spray bar system. Deposited slimes are allowed to dry and then packed to form the outer wall for the dam. The spray bar pipes are reinstalled on the wall and the process repeats itself. Water is temporarily decanted and pumped for reuse in the plant. Dam C acts as a return water facility. The total area covered by the three dams is approximately 55 acres with an average height of 25 metres (Figure 21 and 22).
